REPORT ON

CORNERS OF THE GADASTRAL SURVEY GRID

T. 21 S. R. 8 W., W. Mer., Oregon State.

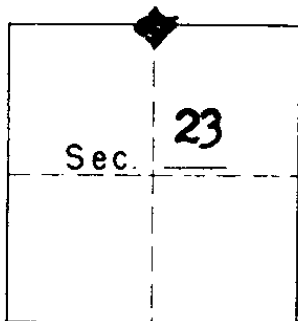
$\frac{1}{4}$ Corner is a brass cap lettered - "U.S. General Land Office Survey - 1954." $\frac{1}{4}$ Corner is in good condition.

1. 20" Douglas fir N 44° E and approximately 30' from $\frac{1}{4}$ corner.
2. 68" Douglas fir S 53° E and approximately 32' from $\frac{1}{4}$ corner.

$\frac{1}{4}$ corner is located on a small flat bench in severely burned green timber. It is approximately 500' southeast of a main ridgetop and approximately 160' south of a mainline logging road.
