REN. T 23 S R 9 W

COR. SECS.

22	23
27	26

Section 23 Twp 23S Rge 9 W 1 Date: June 29, 1964

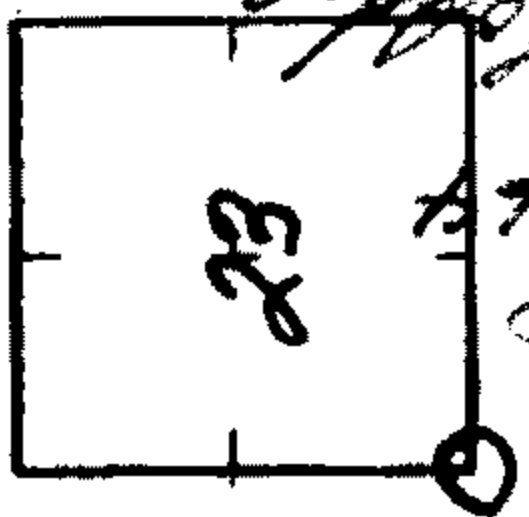
FD. FIR TREE (NOW 42" DIAM.)

N 52° W 66 FT. - PREVIOUSLY
OPENED. - GOOD SCRIBING "S 22" VIS-
IBLE ON OLD FACE,

FD. RED CEDAR (NOW 48" DIAM.)

N 2½° E 46½ FT. - OLD FACE APP-
ARENTLY ROTTED AWAY.

FD. DEAD FIR SNAG S 32° W

33½ FT. - NO SCARS OR OLD FACE
VISIBLE.

THE S.E. TREE IS UPROOTED AND
HAS SLID DOWNHILL FROM WHERE
IT STOOD. - LARGE STUMP HOLE VISIBLE.

AT COR. SET IRON PIPE WITH
BRASS CAP MKD. "COUNTY SURVEYOR'S
OFFICE 1964 T 23 S R 9 W

THE NE & NW ORIG. B.T.'S ARE
STILL ALIVE & IN GOOD CONDITION
OCT. 19, 1964

How was corner identified? 3 B.T.S. / windthrow

Condition of corner: Stake in mound of rocks
