PUBLIC LAND CORNERS

**WEYERHAEUSER TIMBER COMPANY
SPRINGFIELD BRANCH**

TOWNSHIP 23 S RANGE 5 E

SECTION 36 CORNER E 1/4

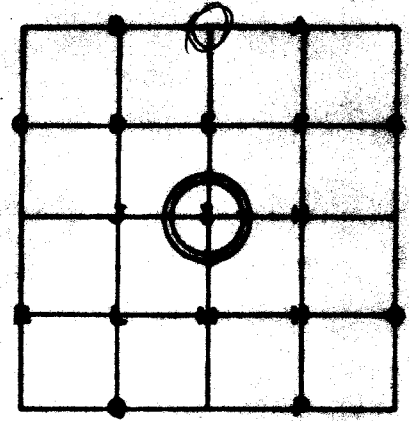
CORNER SET: BRASS CAP MAGNETIC DECLINATION: 20°

BEARING-	FEET-	
S 82° E	76.9	Original BT-Chopped out - Scribing barely visible due to stump rot in tree - a 24" Black Oak.
N 47° W	17.4	A 30" Laurel-Original BT-Chopped out, scribing plainly visible.
N 15° W	32.0	A 7" Chinquapin - newly scribed Gov't. BT.
S 80° W	11.7	A 9" Fir - newly scribed Gov't. BT.

DESCRIPTION OF GROUND COVER AT CORNER: U.S. 00 to the North, logged to
the South. Slightly SE slope.

BEARING -	FEET -	"W" NAIL -	PLATE -	BRASS DISC -
7" Chinquapin	N 15° W	32.0	X	X	New Gov't. 87
9" Fir	S 20½° W	11.7	X	X	New Gov't. 87
