PUBLIC LAND CORNERS

**WEYERHAEUSER TIMBER COMPANY
SPRINGFIELD BRANCH**

TOWNSHIP 25 S RANGE 2 W
 SECTION 20 CORNER Witness to NW
 COUNTY DOUGLAS OREGON

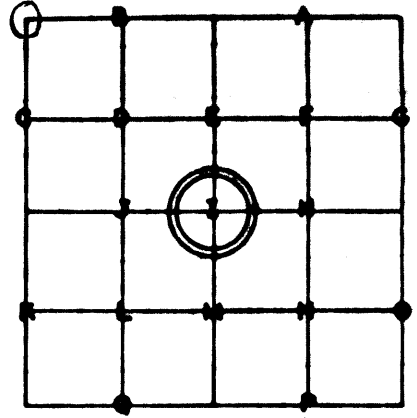
Found - Marked WC - in place

BT's to NW, NE, SE good condition

Dogwood BT to SW down, rotted.

NW corner would be on rock bluff below WC.

BEARING -	FEET -	"W" NAIL -	PLATE -	BRASS DISC -
38" Fir (Orig. BT)	N 16° E	5	X	X	
40" Fir (Orig. BT)	S 44° E	11.6	X	X	
12" Hem.	S 30° W	30.5	X	X	
8" Hem. (Orig. BT)	N 52° W	24.6	X	X
