# PUBLIC LAND CORNERS

WEYERHAEUSER TIMBER COMPANY  
 SPRINGFIELD BRANCH

TOWNSHIP 26 S RANGE 3 E

SECTION 12 CORNER S 1/4

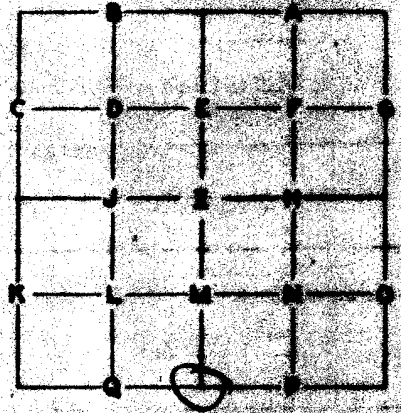
42° FIR STUMP (TREE FILLED)  
 MARK SLIPPED. MARK SCREENING NECESSARY

42° FIR STUMP  
 MARK SLIPPED

NO REFERENCED - SEE PAGE 3

BEARING-	FEET	ORIG. BT	W <sup>2</sup> -NAIL	PLATE	BRASS DISC
42" PINE STUMP	N 51° E	30.3	X	X	X	
60" SUGAR PINE	S 26° E	20.6	X	X	X
