OREGON CORNER RESTORATION FORM

TOWNSHIP 30 RANGE 9

T30S R9W

S6 only
N 1/4 Corner

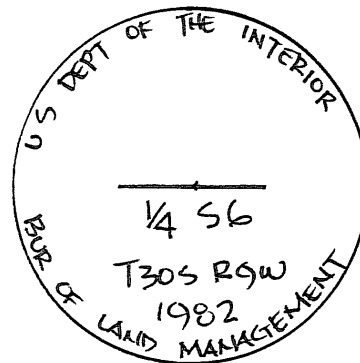
Sketch

We find a 3 1/4" aluminum cap on a 2 1/2" aluminum pipe, 0.2' tall, in good condition and solid in the ground, per Bowder, Farnsworth & Rogers, 1982 (G34, Pg. 15A); Douglas Fir pitch post with yellow BT tag 3' South of monument; 42" Douglas Fir stump, N46°E-43.40'; 16" Hemlock stump, S62°W-35.34'; 48" White Cedar stump, S30°W-54.89'.
