GOVERNMENT CORNER RESTORATION FORM

TOWNSHIP 27 S RANGE 05 W SEC. 19 PLSS # 100372

DOUGLAS COUNTY OREGON

MC  
524 | 519

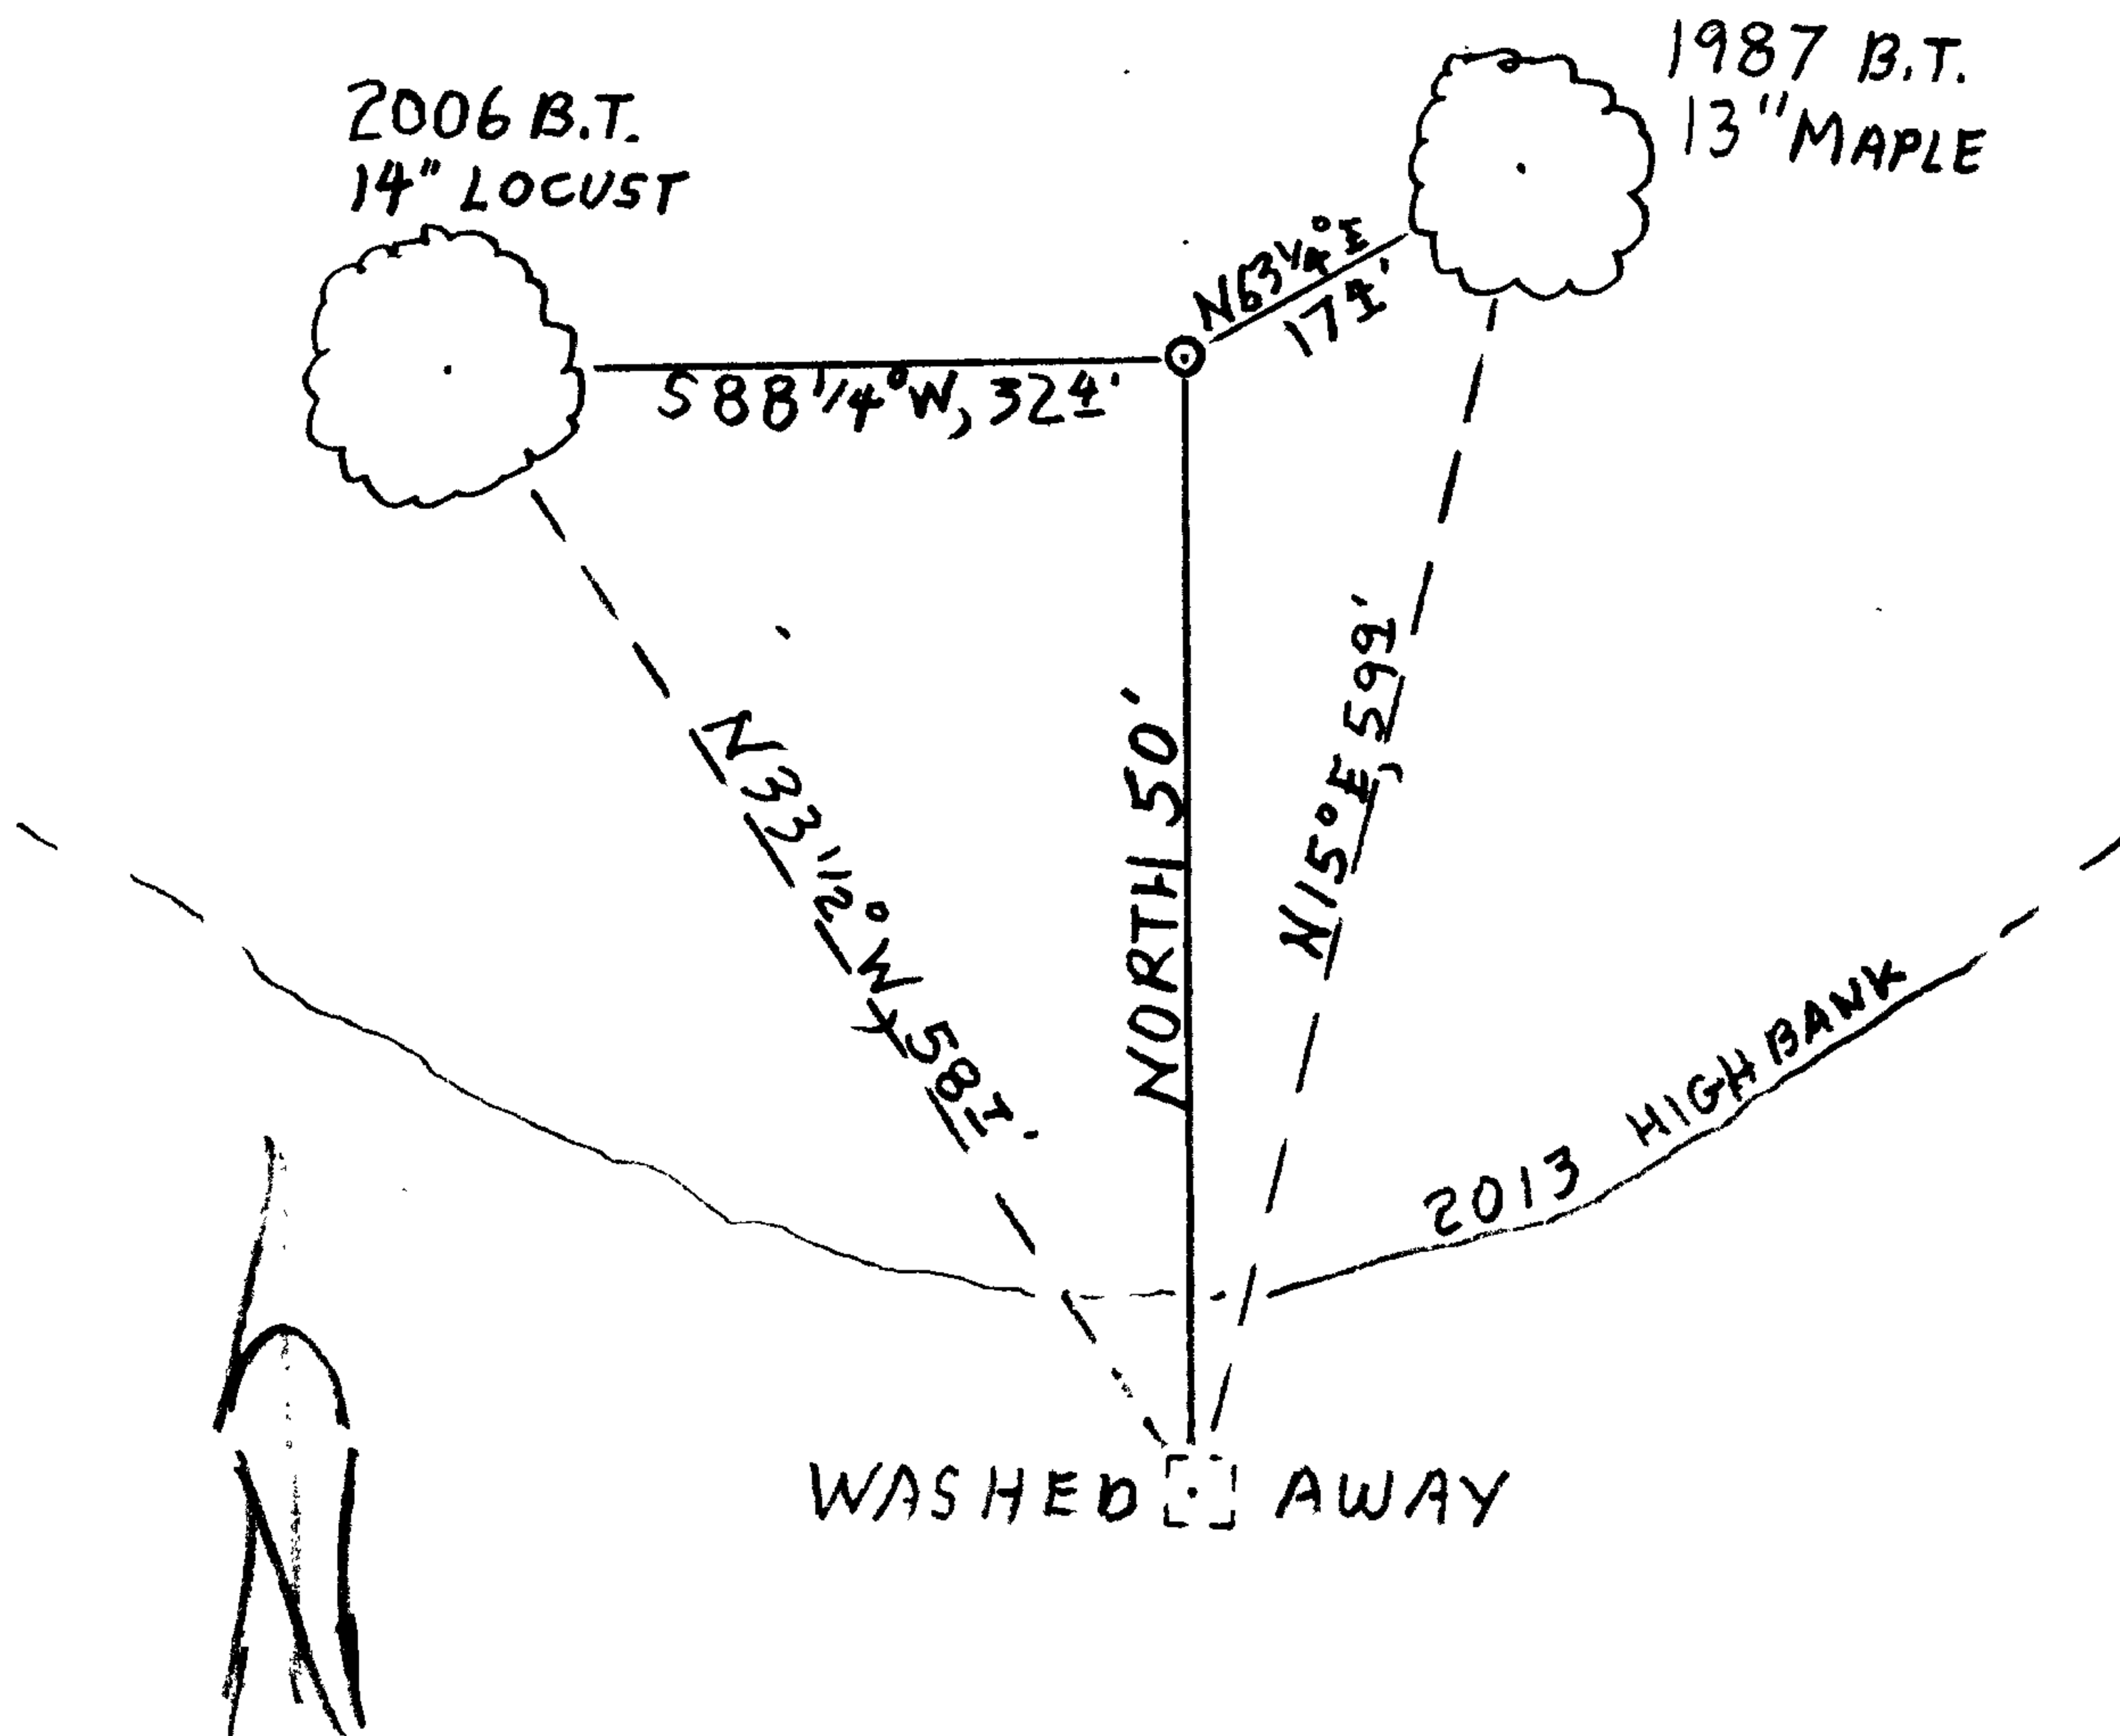
Sketch of Monument, Accessories, and General Area

BRASS CAP / IRON PIPE MONUMENT AS DESCRIBED IN 1966 RENEWAL AND NOTED AS FOUND IN THE 1987 AND 2011 RENEWALS IS NOW WASHED OUT OF POSITION BY FLOODING. MONUMENT IS BURIED UNDER 2 FT. OF SILT, 10+ FEET NE FROM CORNER POSITION.

THE METAL WITNESS POST AND SIGN IS ALSO WASHED FROM ITS 2011 POSITION AND IS NOW BURIED UNDER SILT A FEW FEET FARTHER DOWN-STREAM FROM THE FOUND B.C. (SEE ABOVE).

TWO 2011 BEARING TREES ARE WASHED OUT OF POSITION BY FLOODING AND TWO REMAIN STANDING.  
THE NW'LY 10" LOCUST AND NE'LY 15" LOCUST ARE FALLEN AND WASHED SEVERAL FEET DOWN-STREAM; THEIR ROOT-CROWN POSITIONS ARE BOTH ENTIRELY WASHED AWAY AND CAN NOT BE DETERMINED.  
THE NE 13" DBH MAPLE AND NW 14" DBH LOCUST ARE FOUND AS DESCRIBED.

CORNER IS ON SOUTH END OF ELK ISLAND. EROSION CONTINUES.

MONUMENT POSITION IS IN UNSTABLE GROUND AND IS SUBJECT TO FUTURE FLOODING. MONUMENT COULD BE SET IN FUTURE IF EROSION UNCOVERS BEDROCK.

USING THE TWO FOUND B.T.'S A POSITION IS DETERMINED THAT WOULD BE 50 FEET NORTH FROM THE MEANDER CORNER LOCATION. THIS POSITION IS S 63°14' W, 17 1/2 FEET FROM THE 13" MAPLE B.T. AND N 88°14' E, 32 1/2 FEET FROM THE 14" LOCUST B.T. MEASURING A DISTANCE-DISTANCE INTERSECT FROM THE TWO FOUND B.T.'S THE POINT 50 FEET NORTH FROM THE MEANDER CORNER IS ESTABLISHED AND AT THIS POINT IS SET A 5/8 INCH X 5 FOOT LONG IRON ROD PROTRUDING 6 INCHES ABOVE GROUND.

A METAL WITNESS POST AND SIGN IS SET 1 FOOT SOUTH FROM THE SET 5/8 INCH IRON ROD.
