GOVERNMENT CORNER RESTORATION FORM

TOWNSHIP 25S RANGE 2W SEC. 24 PLSS # 420320

Corner Designation

S.W 1/16 S 24

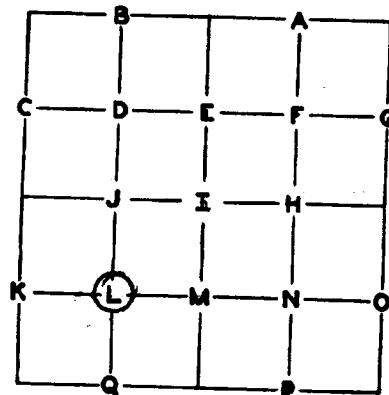
BURNED, SAWN BUT SOLID CEDAR STUMP
 22" x 2 1/2 FT TALL, NO SCRIBING REMAINS
 FOUND A DAVID EDWARDS 2 1/2" B.C.
 SET INTO CENTER OF STUMP
 CAP MARKED "SW 1/16"

BEARING-	FEET-	SURVEY-	
N76°E	22.4	Hosford	20" Hemlock LIGHTLY BURNED ROTTED STUMP 30" x 2 1/2 FT SCRIBING "S24 VISIBLE" N76°E 23.2 TO C.R.C.
S53°W	35.5 TO ORIG FACE)	12" Hemlock LIGHTLY BURNED SAWN STUMP 31" x 2 FT ORIG FACE VISIBLE INSIDE S53°W, 36 1/2 TO C.R.C.
(GO TO PG. 3)			
CS 53/112-36 CS 67/58-16 4/5

NEW REFERENCE: BURNED AND SAWN HEMLOCK STUMP SET 3 1/2" MAG NAIL TOP CENTER
S72°W, 12 3 FT. DIST
