DOUGLAS COUNTY SURVEYOR'S OFFICE

Designation: 90-165 Station: 21+87.37 T 27S R 6W S 14 1/4 NE

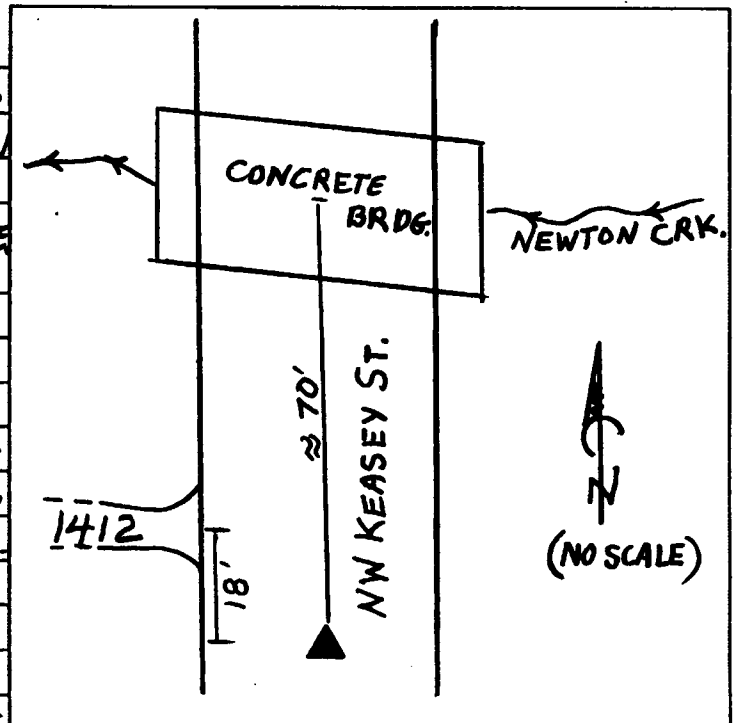
90165

A 2 3/8 INCH DIAM. BRASS CAP
STAMPED "AA SURVEYING INC", ON
A 1 1/2 X 36 INCH GALV. IRON PIPE,
SET BELOW ASPHALT ROAD SURFACE
UNDER AN 11 1/2 INCH DIAM. CAST-
IRON MONUMENT COLLAR AND
COVER.
