OFFICE OF THE  
DOUGLAS COUNTY SURVEYOR

056020

Station: NW COR. DLC 56 T 27 S, R 6 W, Sec 13

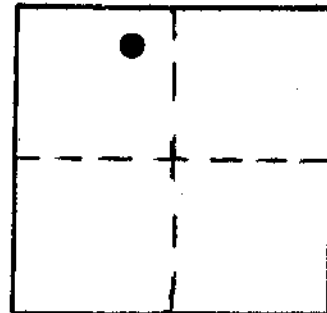
SKETCH

A DCSO disk stamped "T27S R6W DLC 65  
DLC 56 1984" set 5 in. below asphalt  
in a 5 in. dia. 21 in. long concrete filled  
metal water box.

Go to the intersection of Mulholland Dr.  
and NW Garden Valley Blvd. in Roseburg  
Oregon (T27S,R6W,Sec.13) monument is  
approx. 75 ft. east of intersection.

A DCSO disk stamped "I-DID 1972"  
bears N86°33'36"W, 410.95 ft. (grid).
