OFFICE OF THE
DOUGLAS COUNTY SURVEYOR

Station: S 1/4 SEC. 33 ³⁴⁰¹⁰⁰ T 32 S, R 6 W, Sec 33

DESCRIPTION and TO REACH

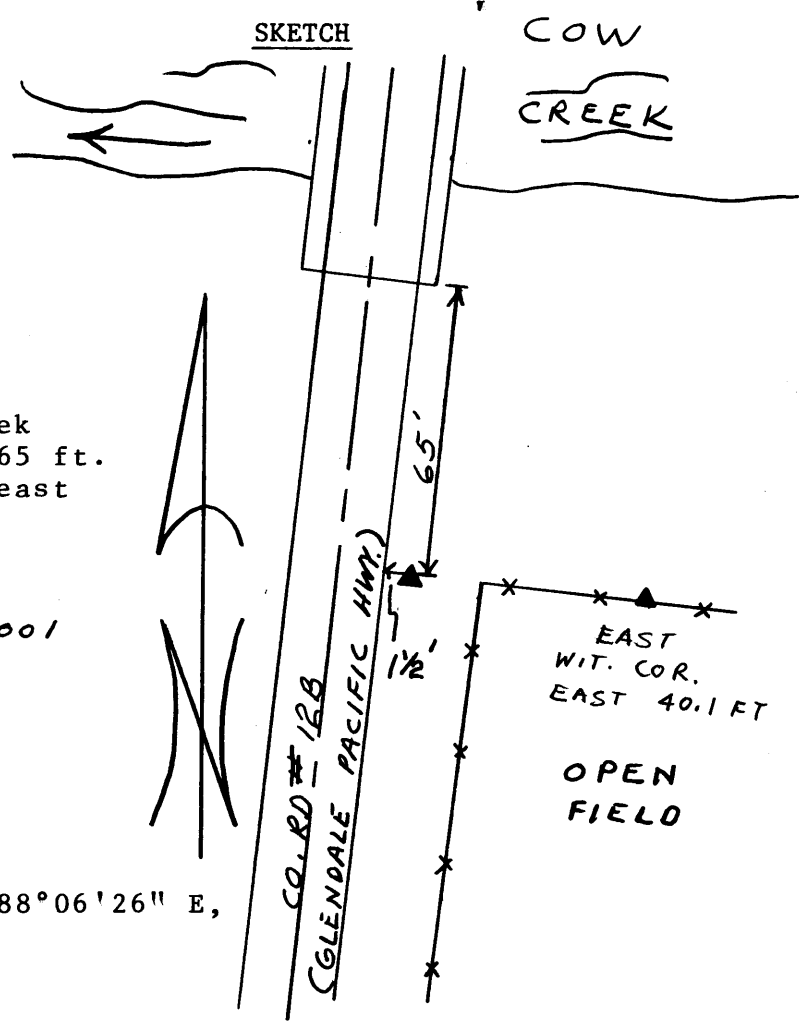
SKETCH

A DCSO disk on an I.P. stamped
"1/4 S 33"
S 4
set 6 in. below ground.

Go to the bridge on Co. Rd. #12B
(Glendale Pacific Hwy.) over Cow Creek
in T33S,R6W,S.33. Corner is approx. 65 ft.
south of bridge and 115 ft. east of east
edge of pavement in road shoulder.

A 1 in. I.P. (E. Wit. Cor.) bears S 88°06'26" E,
40.10 ft. (grid).
