OFFICE OF THE
DOUGLAS COUNTY SURVEYOR

B-090

Station: BREMNER

T 28 S, R 6 W , Sec 20

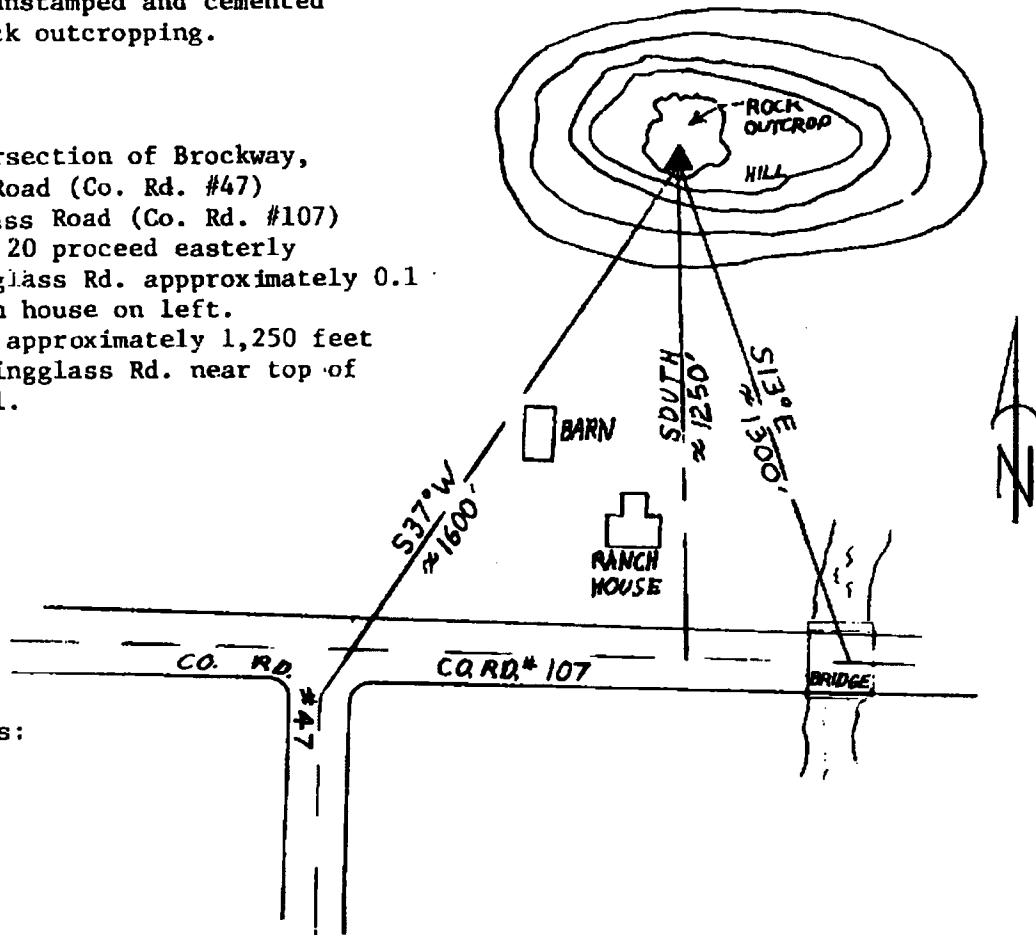
SKETCH

A DCSO disk unstamped and cemented flush in a rock outcropping.

From the intersection of Brockway, Lookingglass Road (Co. Rd. #47) and Lookingglass Road (Co. Rd. #107) T28S, R6W, Sec. 20 proceed easterly along Lookingglass Rd. approximately 0.1 miles to ranch house on left. Monument lies approximately 1,250 feet north of Lookingglass Rd. near top of prominent hill.
