OFFICE OF THE
DOUGLAS COUNTY SURVEYOR

Station: BAD BOB T 21 S, R 11 W, Sec 18
 Set By (Agency): DCSO
 Date Set: 1988
 Recovered By RWS, SJF
 Date Recovered 12/13/88
 Recovered By _____
 Date Recovered _____
 Recovered By _____
 Date Recovered _____

B 116

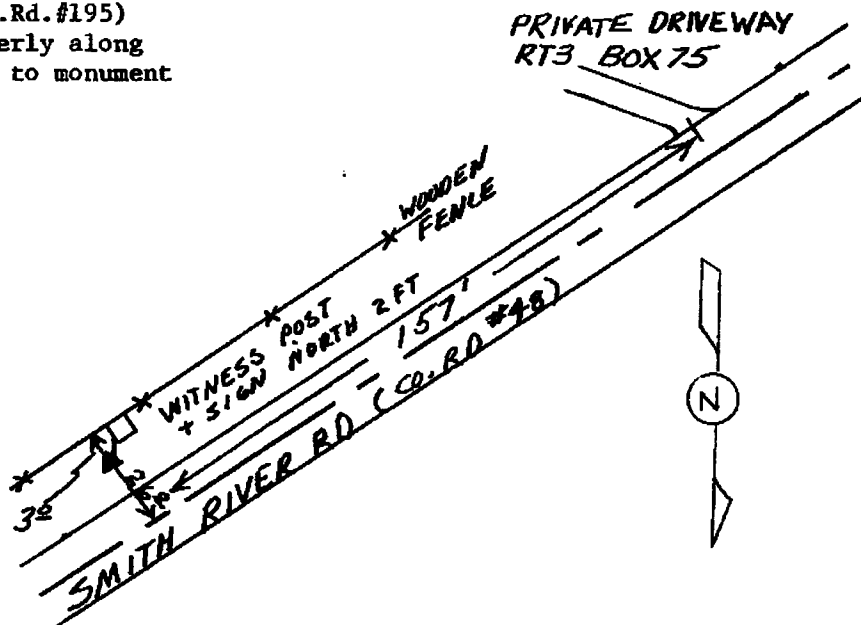
SKETCH

A DCSO disk stamped "BAD BOB 1988" set in a 8" by 36" long concrete filled bell tile set flush with ground.

From the intersection of Smith River Rd. (Co. Rd. #48) and Southside Rd. (Co. Rd. #195) in T21S, R11W, Sec. 19, proceed easterly along Smith River Rd. approx. 1.0 miles to monument on right.
