OFFICE OF THE
DOUGLAS COUNTY SURVEYOR

B-121

Station: BROOM T 27 S, R 7 W, Sec 36
 Set By (Agency): DCSO
 Date Set: 1989
 Recovered By RWS, SJF
 Date Recovered 6/29/89
 Recovered By _____
 Date Recovered _____
 Recovered By _____
 Date Recovered _____

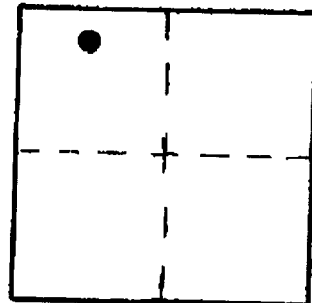
SKETCH

A DCSO disk stamped "BROOM 1989" set in an 8 in. dia. by 42 in. long concrete filled belltile, which protrudes 4 in. above ground.

From the intersection of Colonial Rd. (Co. Rd. #52) and Lookingglass Rd. (Co. Rd. #5D) in T27S, R7W, Sec. 36, proceed northeasterly along Lookingglass Rd. 0.3 miles to monument on left.
