OFFICE OF THE
DOUGLAS COUNTY SURVEYOR

B-158

Station: BENEDICT
Date Set: 1998
Set By (Agency): DCSO
Date Recovered: 12-17-98
Recovered By: RWS SJF

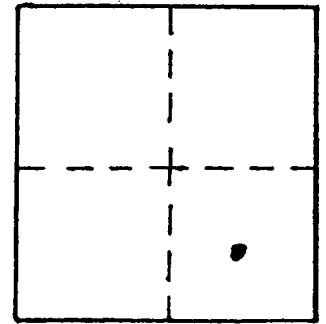
B-158

DCSO BRASS CAP SET IN ROCK OUTCROP STAMPED
"BENEDICT 1998"

FROM THE INTERSECTION OF STATE HWY #2 AND
BENEDICT ROAD (CO. RD #141) IN T29S R7W SEC 6
PROCEED SOUTHERLY ALONG BENEDICT ROAD
0.8 MILES TO MONUMENT ON LEFT.
