R041019A **DOUGLAS COUNTY SURVEYOR'S OFFICE**

Designation: B-182 Station: BEND-1 T 24S R 7W S 30 1/4 SE

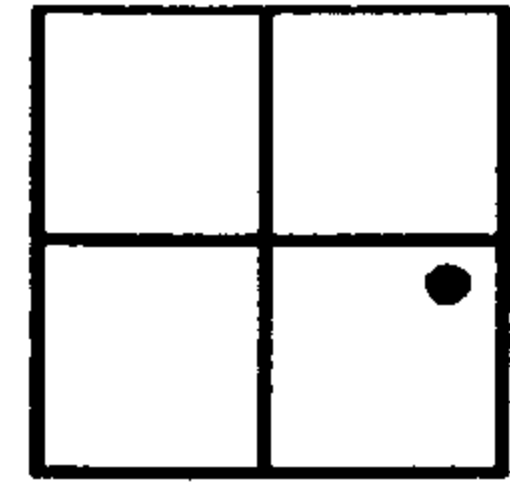
DCSO BRASS CAP STAMPED "BEND-1"
200.3" SET 8" DIA. CONCRETE FILLED
BELL TILE, SET FLUSH WITH
GROUND.
FROM THE INTERSECTION OF TYEE ROAD
(CO. RD #33) AND TYEE BRIDGE ACCESS
ROAD (BLM RD #25-7-5.1) IN T25S
R7W, SEC. 5 PROCEED NORTHERLY
ALONG TYEE ROAD 1.35 MILES TO
INDIAN BEND ROAD ON LEFT, PROCEED
NORTHERLY ON INDIAN BEND ROAD
0.25 MILES TO INTERSECTION
PROCEED NORTHERLY ALONG RIGHT
FORK 0.25 MILES TO MONUMENT
ON LEFT.
