OFFICE OF THE
DOUGLAS COUNTY SURVEYOR

Station: CILLA T 23 S, R 5 W, Sec 10
 Set By (Agency): DCSO
 Date Set: 1974
 Recovered By RWS,SJF
 Date Recovered 9/11/87
 Recovered By _____
 Date Recovered _____
 Recovered By _____
 Date Recovered _____

c-084
CILLA 23S 5W 10

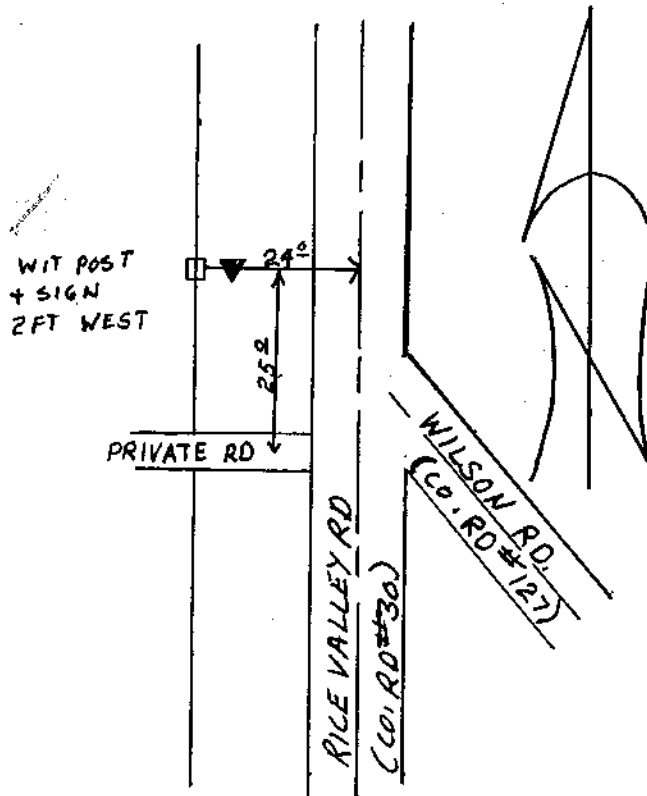
SKETCH

A DCSO disk stamped "CILLA 1974" set in an 8 in. dia. concrete filled belltile protruding 4 in. above ground.

Go to the intersection of Rice Valley Rd. (Co.Rd.#30) and Wilson Rd. (Co.Rd.#127) in T23S,R5W,Sec.10, monument is northwest of intersection.

A DCSO disk stamped " Cilla RM 1 1978"
bears N 61°53'34"E, 65.15 ft. (grid)
 A DCSO disk stamped " Cilla RM 2 1978"
bears S 0°48'29"E, 429.50 ft. (grid).
