OFFICE OF THE
DOUGLAS COUNTY SURVEYOR

Station: CURR T 28 S, R 7W, Sec 2
Set By (Agency): DCSO
Date Set: 3-4-85
Recovered By RWS, SJF
Date Recovered 3-4-85
Recovered By RWS-SJF 9/98
Date Recovered _____
Recovered By _____
Date Recovered _____

DES C-119

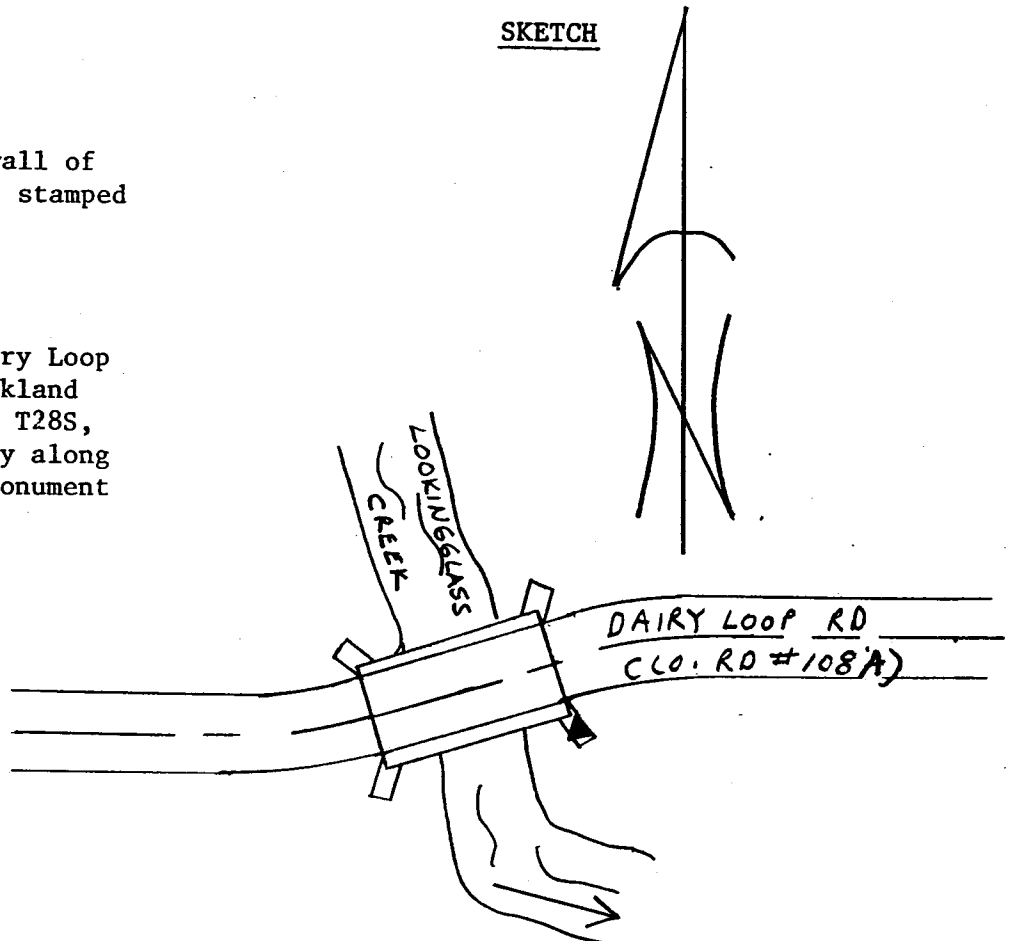
SKETCH

A DCSO brass cap in SE wingwall of bridge over Lookingglass Ck. stamped "CURR 1985."

From the intersection of Dairy Loop Rd. (Co. Rd. 108A) and Strickland Canyon Rd. (Co. Rd. #108) in T28S, R7W, Sec. 3, proceed easterly along Co. Rd. 108A, 0.15 miles to monument on right.
