OFFICE OF THE
DOUGLAS COUNTY SURVEYOR

C-159

Station: CARRIKO
Date Set: 1998
Set By (Agency): DCSO
Date Recovered: 7-14-98
Recovered By: RWS SJF

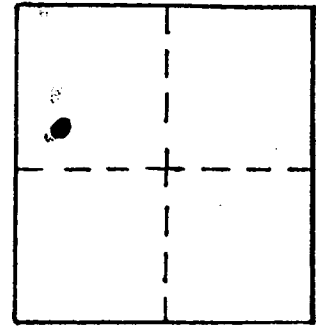
A 3 INCH DIAMETER DCSO DRILL CAP STAMPED "CARRIKO 1998"
SET FLUSH IN TOP OF CONCRETE BRIDGE ABUTMENT.

MONUMENT LIES JUST SOUTH (SEE SKETCH) FROM INTERSECTION
OF DOUGLAS AVENUE (CO. RD. #4A) AND DAWSON ROAD (CO. RD. 148)
IN T27S, R5W, SEC 21.
