DOUGLAS COUNTY SURVEYOR'S OFFICE

Designation: C-176 Station: COUG-1 T 24S R 7W S 13 1/4 SW

DESCRIPTION AND TO REACH

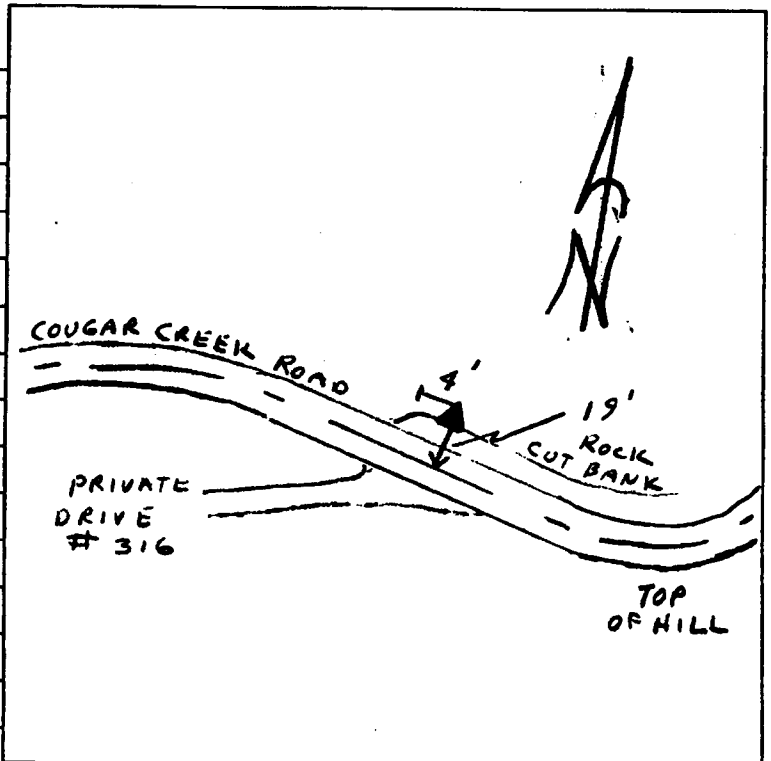
DCSO DRILL CAP STAMPED
"COUG-1 2003" SET IN
TOP OF ROCK CUT BANK
4 FT ABOVE ROAD SURFACE
1/2 FT FROM ROCK EDGE

FROM THE INTERSECTION OF
BULLOCK ROAD (CO. RD #57) AND
COUGAR CREEK ROAD (CO. RD #57C)
IN T24S R7W SEC 13 AT THE
WESTERLY END OF BULLOCK
BRIDGE OVER UNPQUA RIVER
PROCEED SOUTHWESTERLY ALONG
COUGAR CREEK ROAD 0.2 MILES
TO MONUMENT ON RIGHT
