OFFICE OF THE
DOUGLAS COUNTY SURVEYOR
D-089

Station: DAHLIA
Date Set: 1998
Set By (Agency): DCSO
Date Recovered: _____
Recovered By: RWS, SJF

T 26 S, R 6W, Sec 19

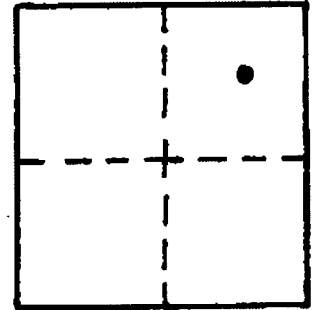
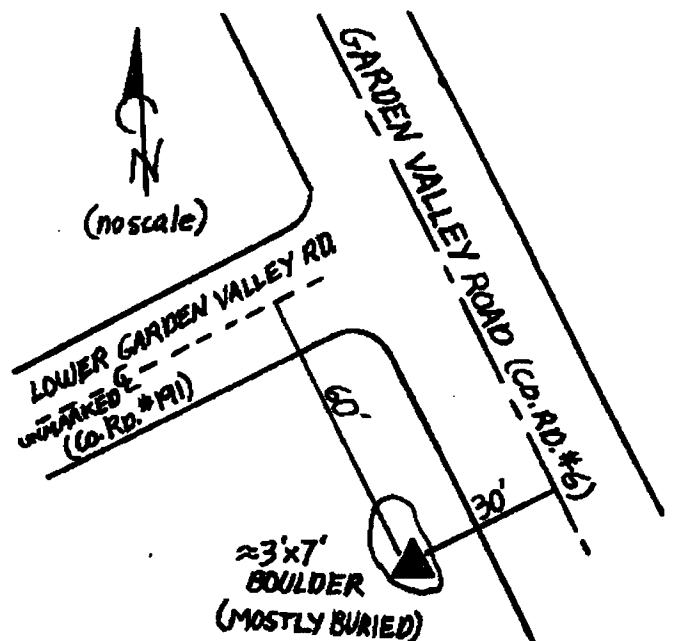
A 3 INCH DIAMETER DCSO DRILL CAP STAMPED "DAHLIA 1998" SET FLUSH IN TOP AND NEAR SOUTH END OF AN APPROXIMATELY 3x7 FOOT BOULDER OF INDETERMINATE DEPTH WHICH LIES MOSTLY BURIED IN ROADWAY FILLBANK.

MONUMENT LIES JUST SOUTH OF INTERSECTION OF GARDEN VALLEY ROAD (Co. RD. #6) AND LOWER GARDEN VALLEY ROAD (Co. RD. #191) IN T26S, R6W, SEC.19. MONUMENT IS SLIGHTLY LOWER THAN AND WEST OF GARDEN VALLEY ROAD WEST SHOULDER.
