DOUGLAS COUNTY SURVEYOR'S OFFICE

Designation: E-047 Station: ELKTON T 225 R 07W S 19 ¼ D

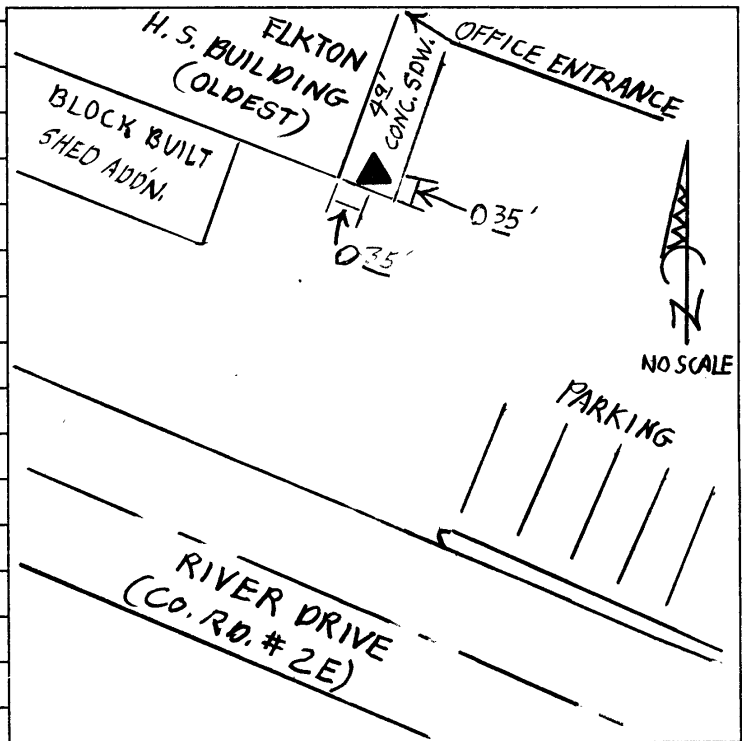
A 3 INCH DIAM. DCSO DRILL CAP STAMPED "ELKTON 2008" SET IN SOUTH END OF CONCRETE SIDEWALK AGAINST THE EASTERLY WALL OF THE OLDEST BUILDING ON THE ELKTON HIGH-SCHOOL CAMPUS.

FROM THE INTERSECTION OF STATE HIGHWAY 38 AND RIVER DRIVE (Co. Rd. # 2E) IN T225, R07W, SECTION 19 PROCEED EAST-SOUTHEASTERLY ALONG RIVER DRIVE APPROX. 0.4 MILES TO MONUMENT ON LEFT.
