OFFICE OF THE
DOUGLAS COUNTY SURVEYOR

Station: FLOUR T 27 S, R 7 W, Sec 12
 Set By (Agency): DCSO
 Date Set: 1989
 Recovered By RWS, SJF
 Date Recovered 5/25/89
 Recovered By _____
 Date Recovered _____
 Recovered By _____
 Date Recovered _____

7-035

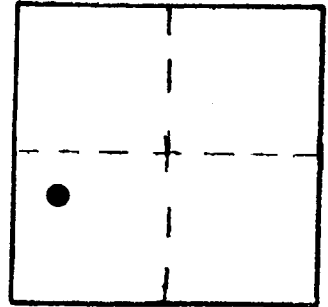
SKETCH

A DCSO drill cap stamped "FLOUR 1989" set in headwall of concrete bridge over Elgrose creek.

Monument is 170 ft. west from the intersection of Melrose Rd. (Co.Rd.#51B) Colonial Rd.(Co.Rd.#52) and Flournoy Valley Rd. (Co.Rd.#51 in T27S,R7W, Sec.12).
