OFFICE OF THE
DOUGLAS COUNTY SURVEYOR

Station: HEN-1
Date Set: 1998
Set By (Agency): DCSO
Date Recovered: 7-28-98
Recovered By: RWS SJF

H-070

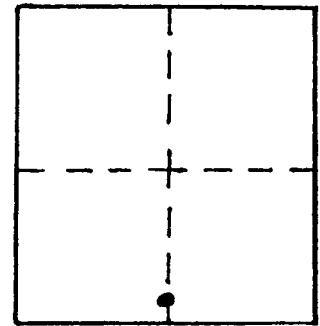
A 2 3/4" DIA DCSO DRILL CAP STAMPED "HEN-1 1998"
IS SET IN AN 8" DIA BY 45" LONG CONCRETE FILLED
BELLTILE, PROTRUSING 7 IN ABOVE GROUND.

FROM THE INTERSECTION OF MEND CREEK ROAD
(CO. RD #11) AND HENDERER ROAD (CO. RD #118)
IN T22S R7W SEC 30, PROCEED NORTHWESTERLY
ALONG HENDERER ROAD 0.5 MILES TO MONUMENT
ON RIGHT.

OPEN FIELD

FIELD ACCESS ROAD
