Station: HEN - 5

T 22 S, R 8W, Sec 22

H-074

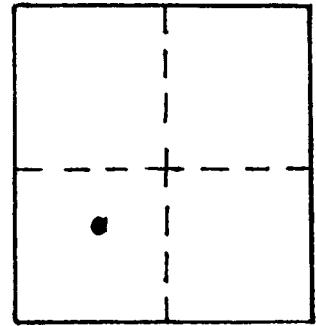
2 3/4" DIA. DCSO DRILL CAP STAMPED "HEN-5 1998"
IS SET IN A 9" DIA CONCRETE FILLED PLASTIC
PIPE, PROTRUS 6" ABOVE GROUND

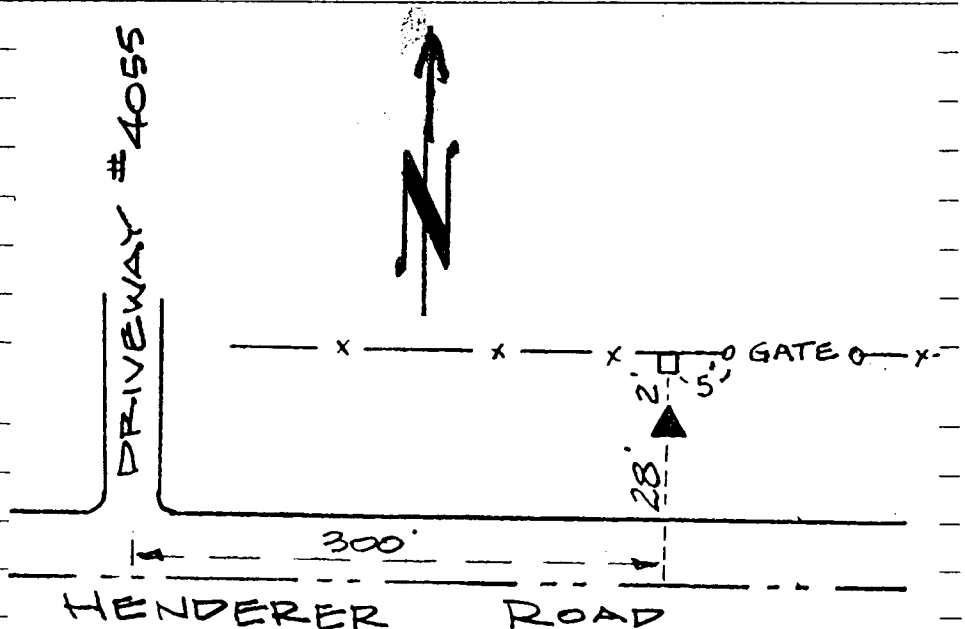
FROM THE INTERSECTION OF HENDERER ROAD
(CO. RD #118) AND MEHL CREEK RD (CO. RD #11)
IN T 22S R 7W SEC 30 PROCEED NORTHWESTERLY
ALONG HENDERER ROAD 3.75 MILE TO MONUMENT
ON RIGHT.
