OFFICE OF THE
DOUGLAS COUNTY SURVEYOR

Station: HEN-6
Date Set: JULY, 1998
Set By (Agency): DCSO
Date Recovered: 7/30/98
Recovered By: RWS SJF

H-075

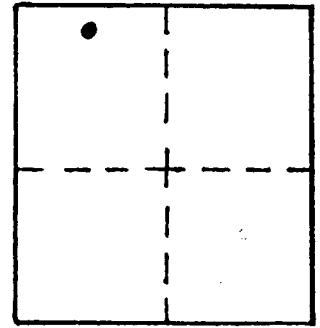
A DCSO DISK STAMPED "HEN-6 1998" SET FLUSH IN TOP OF CONCRETE FILLED 9 INCH O.D. PLASTIC PIPE FIRMLY SET AND PROTRUDING 6 INCHES ABOVE GROUND.

FROM THE INTERSECTION OF MEHL CREEK ROAD (CORP. # 67) AND HENDERER ROAD (CORP. # 118) IN T22S, R7W, SEC. 30 PROCEED NORTHWESTERLY ALONG HENDERER ROAD APPROXIMATELY 4.45 MILES TO MONUMENT ON LEFT.
