OFFICE OF THE
DOUGLAS COUNTY SURVEYOR

H-080

Station: HUBBA-2

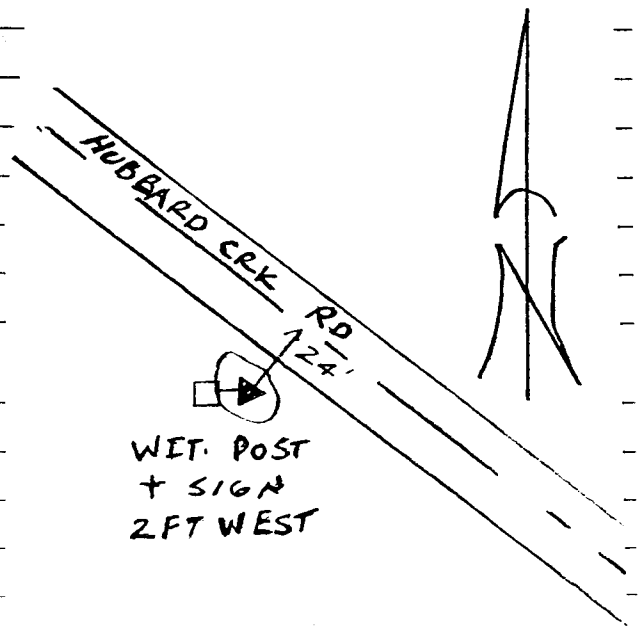
FROM THE INTERSECTION OF MELQUA RD (CO RD #13A)
AND HUBBARD CRK RD (CO RD #6) IN T25S R7W SEC26
PROCEED 1/4 MILE WESTERLY ALONG HUBBARD CRK RD
1/5 MILES TO MONUMENT ON LEFT.

DCSO DRILL CAP SET IN TOP OF A 3'X2'X3'
HIGH ROCK OUT CROP IN CUT BANK. BRASS CAP
STAMPED "HUBBA-2 2000"
