OFFICE OF THE
DOUGLAS COUNTY SURVEYOR

Station: HUBBA -3

T 25 S, R 7W, Sec 21

H-081

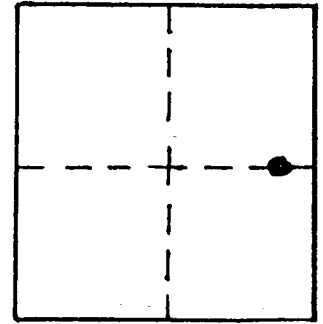
From THE INTERSECTION OF MELQUA RD (CORD #13A)
AND HUBBARD CRK RD (CORD #6) IN T25S R7W
SEC 26 PROCEED WESTERLY ALONG
HUBBARD CRK RD 255 METERS TO MONUMENT ON
LEFT IN ROCK OUT CROP.

DCSO DRILL CAP SET IN TOP OF A 6' X 3' X
4' HIGH ROCK OUT CROP IN ROAD CUT
BANK. BRASS CAP STAMPED "HUBBA-3 2000"
