OFFICE OF THE
DOUGLAS COUNTY SURVEYOR

Station: HUBBA-5

T 25 S, R 57N, Sec 20

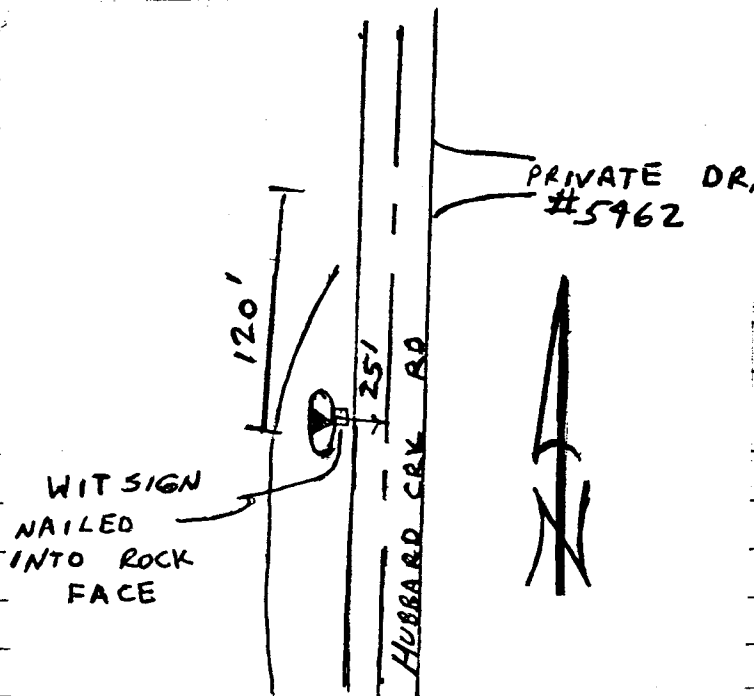
Reference Marks:

DCSO DRILL CAP SET NEAR TOP OF A 2' X 5"
EXPOSED ROCK CUT BANK IN A SMALL LEDGE.
STAMPED "HUBBA-5 2000".
