OFFICE OF THE
DOUGLAS COUNTY SURVEYOR

Station: M76 T 29 S, R 5W , Sec 22

M-076
M76 29S 5W 22

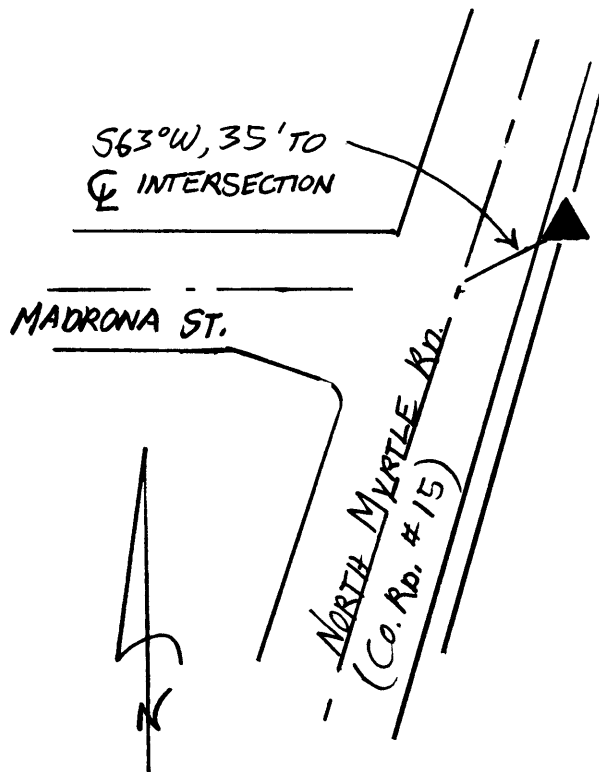
SKETCH

Found: A standard DCSO disk stamped "M76 1991".
set in concrete curb.

To Reach: At the intersection of North Myrtle Rd.
(Co. Rd. #15) and Madrona St. in Myrtle
Creek.
