OFFICE OF THE  
DOUGLAS COUNTY SURVEYOR

Station: NU 3 T 26 S, R 6 W, Sec 28

A DCSO disk stamped "NU 3 1972"  
set in a boulder flush with ground.

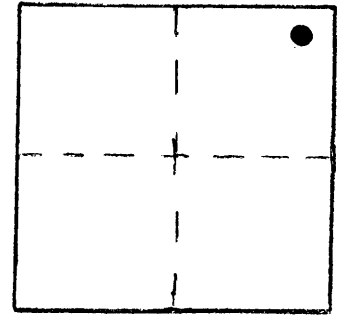
SKETCH

Go to the intersection  
of Garden Valley Rd.  
( Co. Rd. #31A) and  
Del Rio Rd.  
(Co. Rd. #31C) in T26S, R6W,  
Sec. 28. Monument lies on  
north edge of intersection.

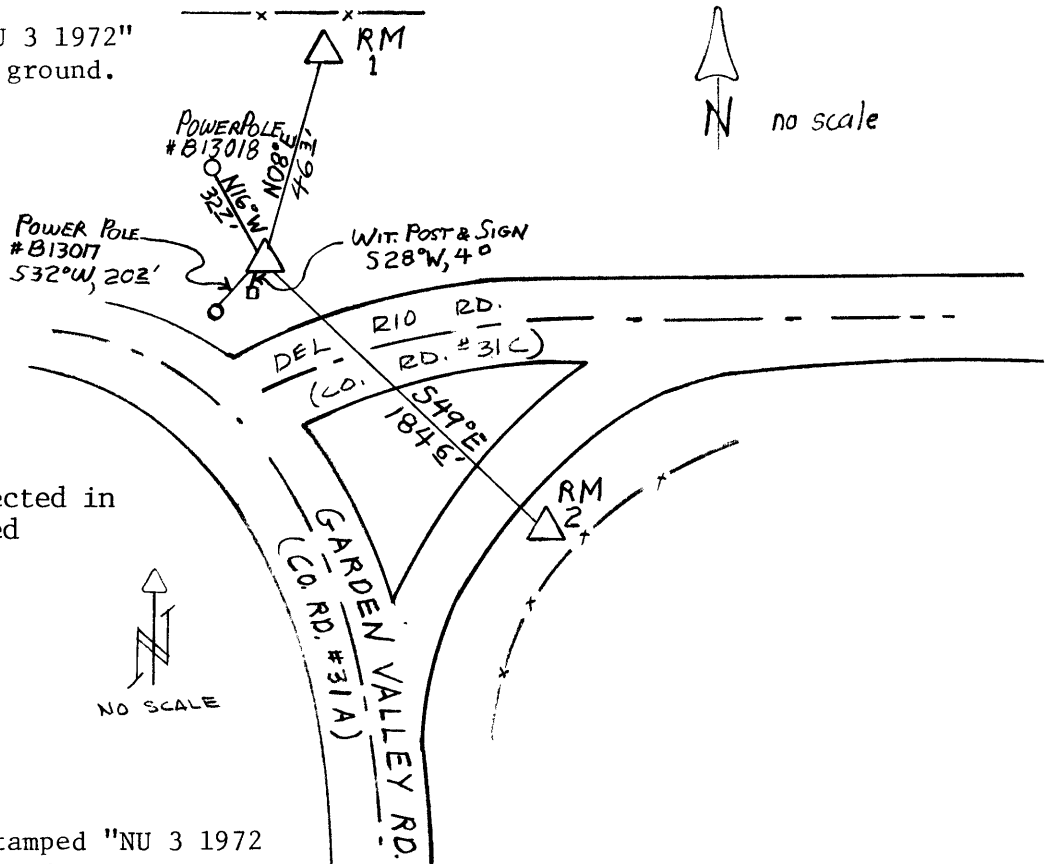
A standard DCSO disk stamped "NU 3 1972  
RM 1 1979" set in an 8 inch o.d. concrete  
filled bell tile set flush with ground, bears  
N10°02'13"E, 46.25 ft. distant (grid).

A standard DCSO disk stamped "NU 3 1972 RM 2 1979" set in an 8 inch o.d. concrete  
filled bell tile set flush with ground, bears S47°10'12"E, 184.58 ft. distant (grid).
