OFFICE OF THE  
DOUGLAS COUNTY SURVEYOR

0-025

Station: OLA-4  
Date Set: Nov, 1998  
Set By (Agency): DCSO  
Date Recovered: 11/23/98  
Recovered By: RWS, SJF

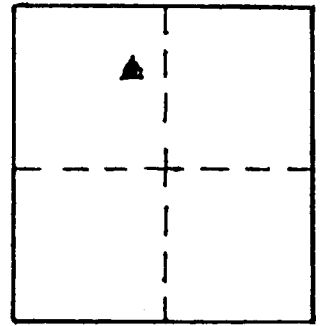
A 3 INCH DIAMETER D.C.S.O. DRILL CAP STAMPED "OLA-4-1998"  
SET FLUSH IN ROCK OUTCROPPING PROTRUDING APPROXIMATELY  
2 1/2 FEET ABOVE ROAD SURFACE.

FROM THE INTERSECTION OF HOOVER HILL RD. (CO. RD. #129)  
AND OLALLA RD. (CO. RD. #38) IN T28S, R7W, SEC 34 PROCEED  
NORTHERLY ALONG OLALLA RD. APPROXIMATELY 0.40 MILES  
TO MONUMENT ON RIGHT.
