OFFICE OF THE
DOUGLAS COUNTY SURVEYOR

Station: PINES
Set By (Agency): DCSO
Date Set: 1989
Recovered By RWS, SJF
Date Recovered 5/1/89
Recovered By _____
Date Recovered _____
Recovered By _____
Date Recovered _____

T 27 S, R 6 W , Sec 30

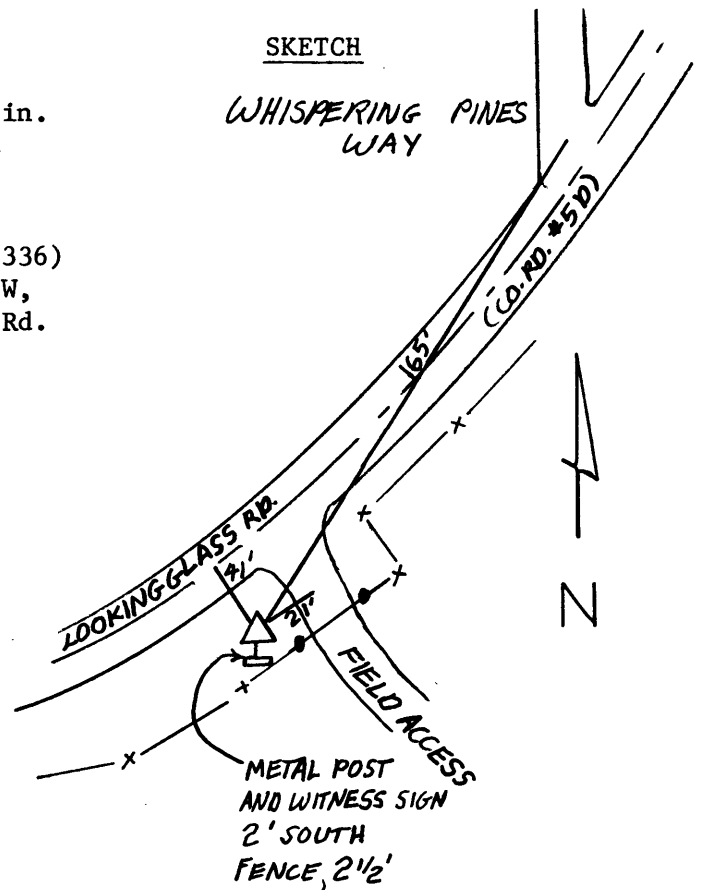
SKETCH

A DCSO disk stamped "PINES 1989" set in a 8 in. dia. by 42 in. long concrete filled belltile which is set flush with ground.

From the intersection of Nandy Lane (Co.Rd.#336) and Lookingglass Rd. (Co.Rd.#5D) in T27S,R7W, Sec.25, proceed easterly along Lookingglass Rd. approx. 0.7 miles to monument on right.
