DOUGLAS COUNTY SURVEYOR'S OFFICE

Designation: P-128 Station: PRUNE-1 T 30S R 6W S 12 ¼ SE

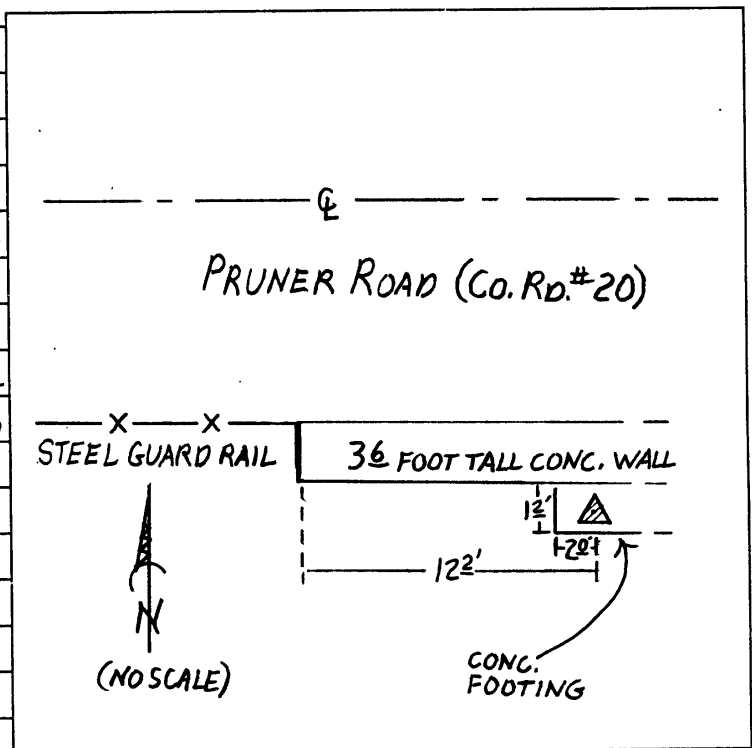
A 3 INCH DIAM. DCSO DRILL
CAP STAMPED "PRUNE-1 2012" IS
SET IN TOP OF CONCRETE FOOTING
AT SOUTH WEST CORNER OF WEST
ABUTMENT OF BRIDGE OVER SOUTH
UMPUA RIVER (BRIDGE BUILT 2009)

FROM THE INTERSECTION OF INTER-
STATE HIGHWAY 5 AND PRUNER ROAD
(CO. RD. #20) IN T30S, R5W, SECTION 7
PROCEED WEST ALONG PRUNER ROAD
APPROX. 0.60 MILES TO MONUMENT ON
LEFT.
