**DOUGLAS COUNTY SURVEYOR'S OFFICE**

Designation: P-129 Station: PRUNE-2 T 30S R 5W S 07 ¼ SW

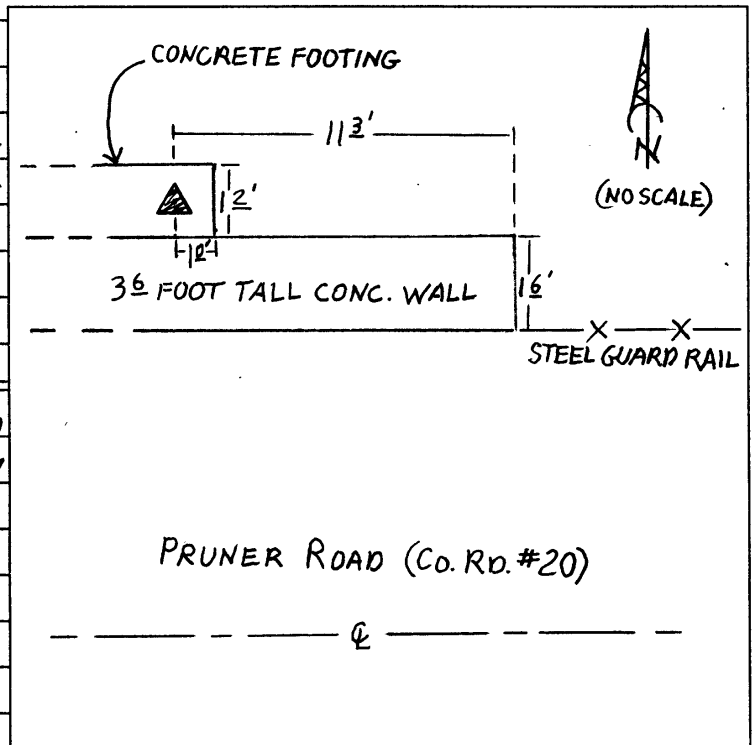
A 3 INCH DIAM. DCSO DRILL CAP  
STAMPED "PRUNE-2 2012" IS SET IN  
TOP OF CONCRETE FOOTING AT NORTH-  
EAST CORNER OF EAST ABUTMENT OF  
BRIDGE OVER SOUTH UMPQUA RIVER  
(BRIDGE BUILT 2009).

FROM THE INTERSECTION OF INTER-  
STATE HIGHWAY 5 AND PRUNER ROAD  
(Co. Rd. # 20) IN T30S, R5W, SECTION 7  
PROCEED WEST ALONG PRUNER  
ROAD APPROX. 0.45 MILES TO  
MONUMENT ON RIGHT.
