OFFICE OF THE
DOUGLAS COUNTY SURVEYOR

Station: Robin RM 1

T 28 S, R 4W , Sec 34

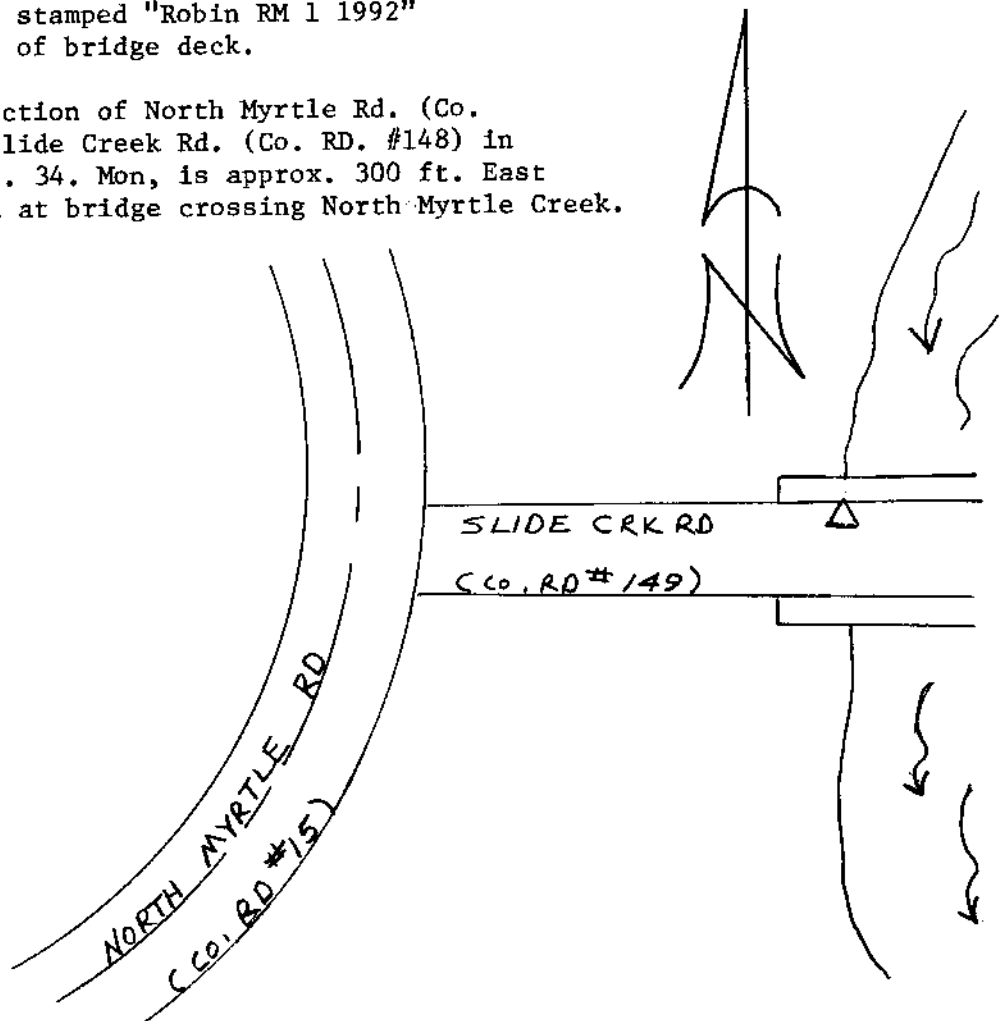
SKETCH

Set: A standard DCSO disk stamped "Robin RM 1 1992"
set in the NW corner of bridge deck.

To Reach: At the intersection of North Myrtle Rd. (Co.
Rd. #15; and Slide Creek Rd. (Co. RD. #148) in
T28S, R4W, sec. 34. Mon, is approx. 300 ft. East
on Slide Creek at bridge crossing North Myrtle Creek.
