OFFICE OF THE  
DOUGLAS COUNTY SURVEYOR

Station: STENADD

DCSO Designation: S-155

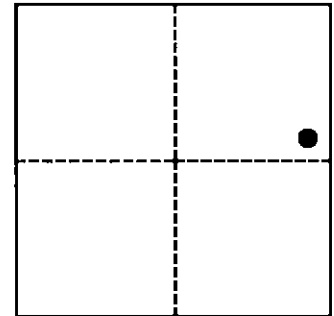
Description: A 2 inch I.D. X 36 inch long galvanized iron pipe with a 5/8 inch iron rod, with a plastic cap marked BENTZ SURVEY INC. in center, set approx. 6 inches below ground.

To reach: From the intersection of Del Rio Rd. (Co. Rd. #31C) and Garden Valley Rd. (Co. Rd. #31A) in T26S R6W Sec. 28 proceed southerly along Garden Valley Rd. approx. 1,100 feet to monument on left approx. 550 feet east from road right-of-way.
