OFFICE OF THE  
DOUGLAS COUNTY SURVEYOR

Station: STENBECK  
Date Set: 10-86  
Set By (Agency): BENTZ SURVEY  
DCSO Designation: S-156  
Date Recovered: 11-86  
Recovered By: SJF RWS  
Date Recovered: \_\_\_\_\_  
Recovered By: \_\_\_\_\_  
Date Recovered: \_\_\_\_\_  
Recovered By: \_\_\_\_\_

T26W R6W Sec. 28

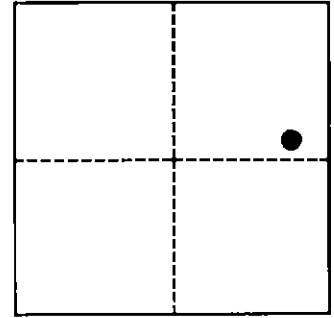
Description: A 2 inch I.D. X 36 inch long galvanized iron pipe with a 5/8 inch iron rod, with a plastic cap marked BENTZ SURVEYING INC. in center, set approx. 6 inches below ground.

To reach: From the intersection of Del Rio Rd. (Co. Rd. #31C) and Garden Valley Rd. (Co. Rd. #31A) in T26S R6W Sec28 proceed southerly along Garden Valley Rd. approx. 1,100 feet to monument on left at east edge of road right-of-way in fence line.
