OFFICE OF THE
DOUGLAS COUNTY SURVEYOR

Station: SOUCI, T 27 S, R 6 W, Sec 16

S-163

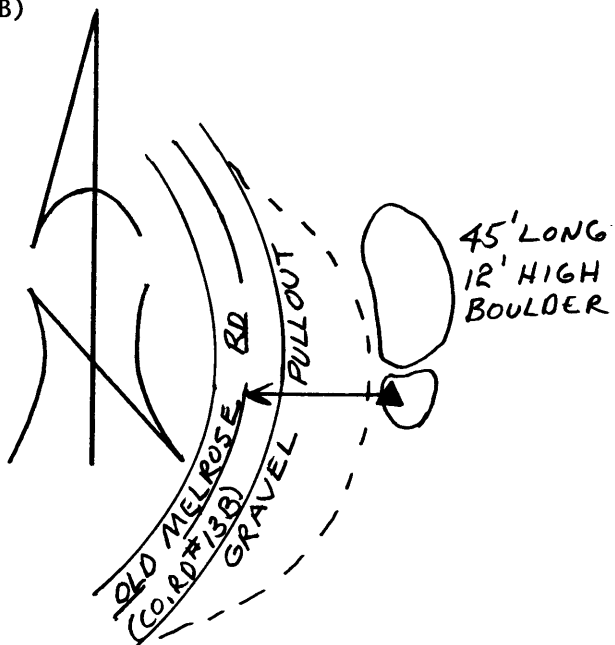
SKETCH

A DCSO disk stamped "SOUCI 1989" set near west edge of a 5 ft. by 6 ft. by 4 ft. high boulder, disk is 3 ft. above ground.

From the intersection of Old Melrose Rd. (Co.Rd.#13B) and San Souci Dr. (Co.Rd.#326A) in T27S,R6W,Sec.16, proceed southeasterly along Old Melrose Rd. approx. 0.15 miles to a sharp right hand curve, monument is on left.
