OFFICE OF THE
DOUGLAS COUNTY SURVEYOR

S-179

Station: SCR-1

T 28 S, R 7W, Sec 22

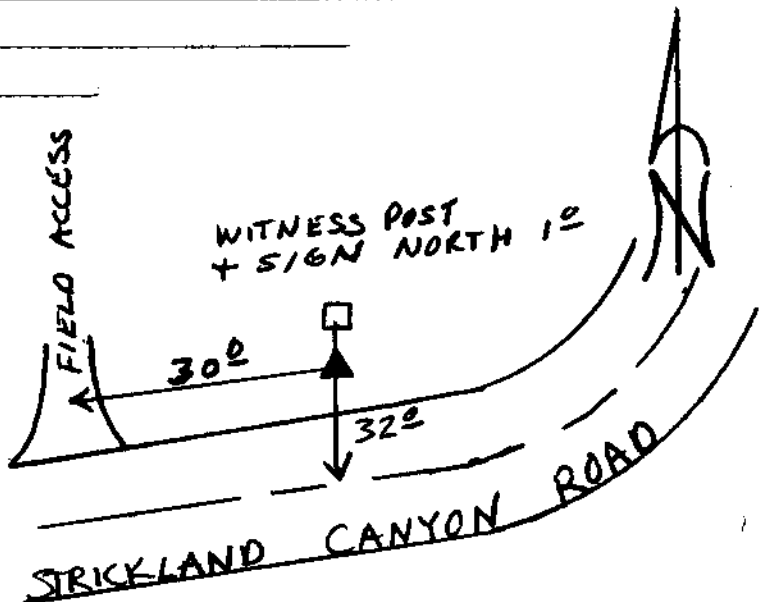
Reference Marks:

A DCSO DISK STAMPED "SCR-1 1998" SET FLUSH
IN TOP CONCRETE FILLED 8x45 INCH CONCRETE BELL TILE
FIRMLY SET AND PROTRUDING APPROXIMATELY 7 INCHES ABOVE
GROUND. MONUMENT IS NEAR TOP OF APPROX. 6 FOOT TALL CUT-BANK.
FROM THE INTERSECTION OF STATE HIGHWAY 42 AND
STRICKLAND CANYON ROAD (Co. Rd. # 100) IN T28S, R7W, SEC. 27
PROCEED NORTHERLY ALONG STRICKLAND CANYON
ROAD APPROXIMATELY 0.55 MILES TO MONUMENT ON LEFT.
