OFFICE OF THE
DOUGLAS COUNTY SURVEYOR

S-183

Station: SCR-6

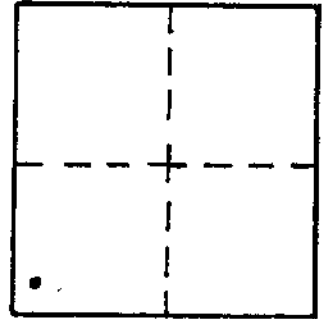
2 3/4" DIA DCSO DRILL CAP STAMPED "SCR-6 1998"
SET IN AN 8" DIA BY 45" LONG CONCRETE
FILLED BELL TILE, PROTRUSORS 8" IN ABOVE GROUND.

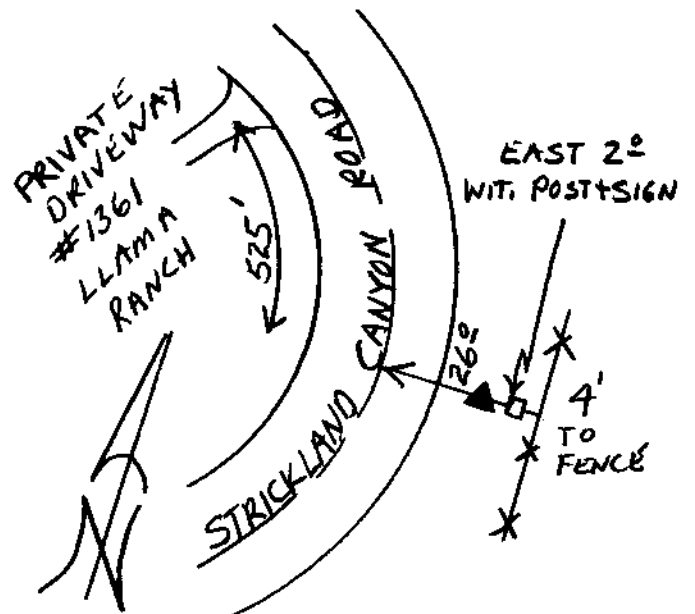
Reference Marks:

FROM THE INTERSECTION OF STATE HWY 60
AND STRICKLAND CANYON ROAD (CO. RD #100)
IN T28S R7W SEC 27, PROCEED NORTHERLY
ALONG STRICKLAND CANYON ROAD 3.7 MILES
TO MONUMENT ON RIGHT.
