OFFICE OF THE  
DOUGLAS COUNTY SURVEYOR

Station: SCR-7

T 28 S, R 7W, Sec 10

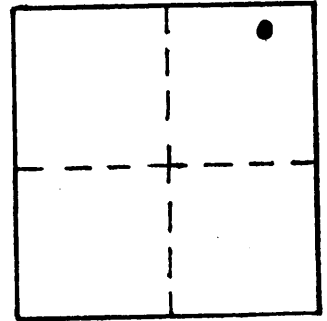
S-104

A DCSO DRILL CAP STAMPED "SCR-7 1998" SET  
FLUSH IN TOP OF CONCRETE BOX CULVERT HEADWALL OF  
CHANNELED STREAMBED RUNNING WEST TO EAST  
FROM THE INTERSECTION OF STATE HIGHWAY 42 AND  
STRICKLAND CANYON ROAD (CO. RD. # 108) IN T28S, R7W, SEC 27  
PROCEED EASTERLY AND NORTHERLY ALONG STRICKLAND CANYON  
RD. APPROXIMATELY 4.5 MILES TO MONUMENT ON RIGHT.
