DOUGLAS COUNTY SURVEYOR'S OFFICE

Designation: S-213 Station: SKODA T 22S R 13W S 23 1/4 LOT 2

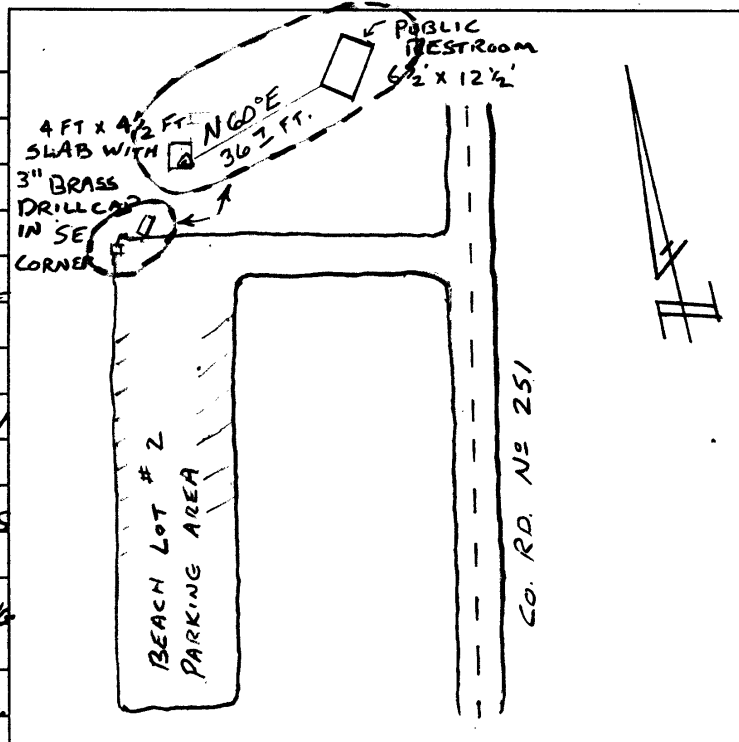
A 3 INCH DIAM. D.C.S.O. BRASS
DRILL CAP STAMPED "SKODA 2006"
SET IN SOUTHEASTERLY CORNER OF
4 X 4 1/2 FOOT CONCRETE SLAB (FORM-
ING FOUNDATION OF PARKING-FEE COLLEC-
TION BOX.)

FROM THE INTERSECTION OF SALMON
HARBOR DRIVE (Co. Rd. #251) AND
THE UMPQUA SOUTH JETTY BEACH ACCESS
RD. IN T22S, R3W, SECTION 13
PROCEED SOUTH SOUTHWESTERLY ALONG
SALMON HARBOR DRIVE (Co. Rd. #251)
0.9 MILES TO ENTRANCE TO BEACH LOT #2.
MONUMENT IS AT WEST EDGE AND NORTH
END OF PARKING LOT.
