**DOUGLAS COUNTY SURVEYOR'S OFFICE**

Designation: S-214 Station: STAGING T 22 S R 13 W S 13 ¼ SW

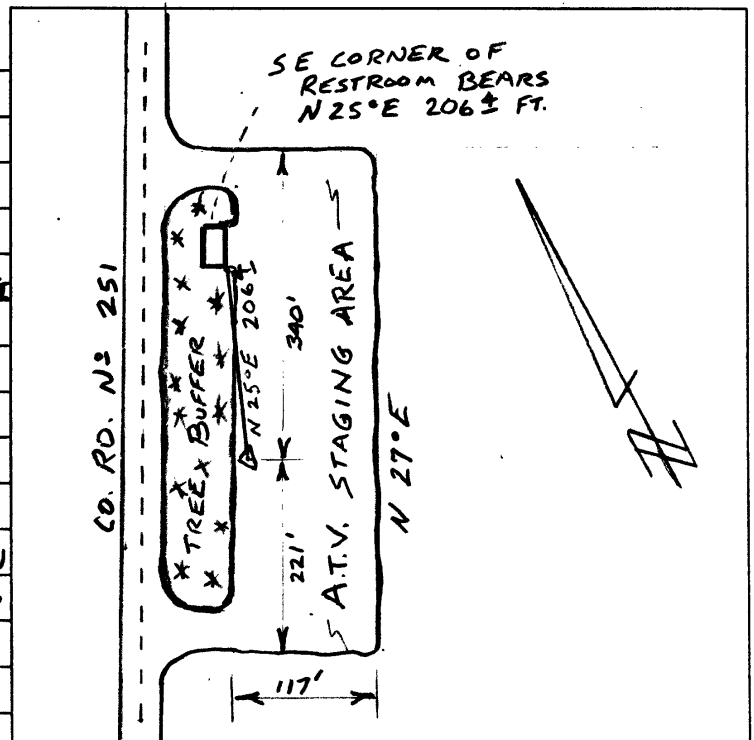
#100-1288 (3/12/08 renamed S-214)

A 5/8" DIA. REBAR 5 FT. IN LENGTH,  
CENTER PUNCHED, IS DRIVEN JUST BELOW  
SURFACE OF WESTERLY EDGE OF PAVED  
ATV STAGING AREA APPROX 2.4 FT.  
EAST OF CONCRETE CURB. S.E. CORNER  
OF PUBLIC RESTROOM BEARS N25°E, 206 ± FT.

FROM THE INTERSECTION OF CO. RD. N°  
251 AND UMPQUA SOUTH JETTY BEACH  
ACCESS RD. IN T.22S R.13W SEC. 13  
PROCEED SOUTHERLY APPROX. 100 FT.  
TO A.T.V. STAGING AREA ENTRANCE ON  
LEFT. ENTER AND PROCEED SOUTHERLY APP.  
340 FT. TO MONUMENT ON RIGHT.
