OFFICE OF THE
DOUGLAS COUNTY SURVEYOR

S-216

Station: SWAN-RESET T 28 S, R 6W , Sec 18
 Set By (Agency): IE ENGINEERING
 Date Set: 3/4/2017
 Recovered By _____
 Date Recovered _____
 Recovered By _____
 Date Recovered _____
 Recovered By _____
 Date Recovered _____

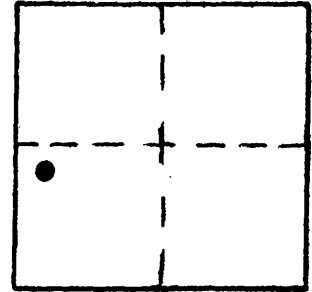
A BRASS CAP SET IN THE NORTHWEST
CORNER OF BRIDGE OVER LOOKINGGLASS
CREEK STAMPED: SWAN RESET

From the intersection of Looking-
glass Rd. (Co. Rd. #47) and
Happy Valley Rd. (Co. Rd. #26) in
T28S, R6W, Sec. 7, proceed southerly
along Lookingglass Rd. 1.0 miles to
monument on right.
