t-056
TURKEY HILL

DOUGLAS COUNTY SURVEYOR

Station: Turkey Hill

T-056

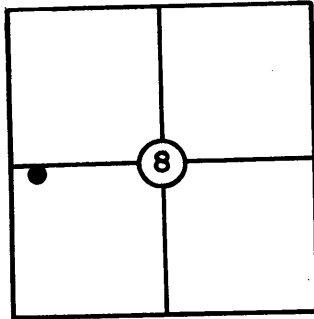
SKETCH

DESCRIPTION: A Brass cap stamped "Turkey

Hill 1977" set in a drill hole in a 3 1/2

ft. sq. conc. footing near the SW cor of the

footing 4 ft W. of the E. R/W fence of I-5

between the freeway & a dead-end Frontage Rd.

47 ft. South of the South end of a freeway
guardrail, and 4 ft. West of a metal witness
post.
