OFFICE OF THE  
DOUGLAS COUNTY SURVEYOR

Station: TAILFIN  
 Date Set: 1990  
 Set By (Agency): DCSO  
 Date Recovered: 1/7/91  
 Recovered By: SJF,TF  
 Date Recovered: \_\_\_\_\_  
 Recovered By: \_\_\_\_\_  
 Date Recovered: \_\_\_\_\_  
 Recovered By: \_\_\_\_\_

T-073

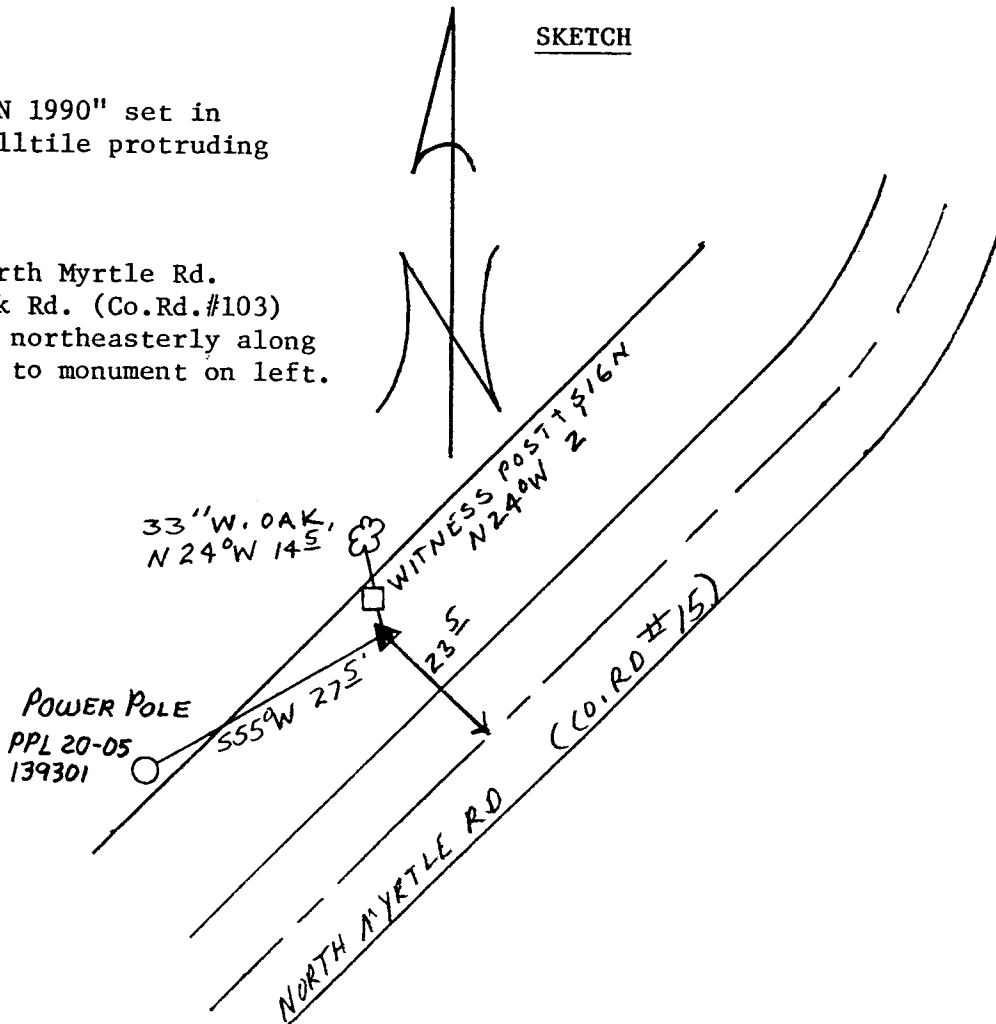
SKETCH

A DCSO disk stamped "TAILFIN 1990" set in a 8"x40" concrete filled belltile protruding 6" above ground.

From the intersection of North Myrtle Rd. (Co.Rd.#15) and Bilger Creek Rd. (Co.Rd.#103) in T29S,R5W,Sec.14, proceed northeasterly along North Myrtle Rd. 1.65 miles to monument on left.
