OFFICE OF THE  
DOUGLAS COUNTY SURVEYOR

Station: U55 T 22 S, R 7 W, Sec 30

DESCRIPTION and TO REACH

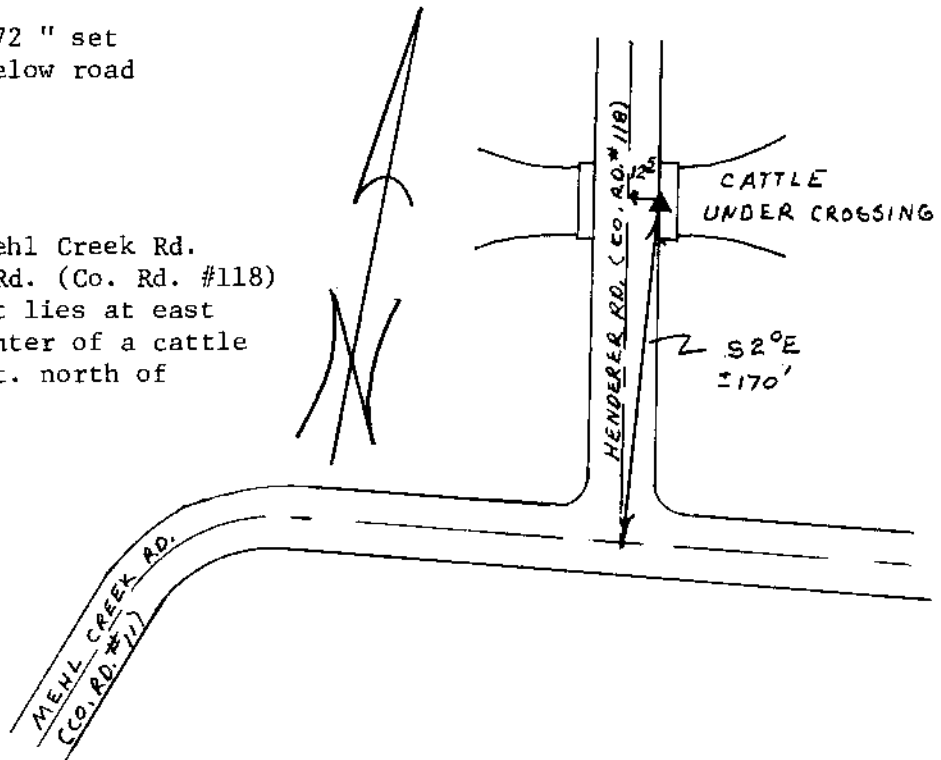
SKETCH

A DCSO disk stamped "U55:1972" set in concrete approx. 6 in. below road shoulder surface.

Go to the intersection of Mehl Creek Rd. (Co. Rd. #11) and Henderer Rd. (Co. Rd. #118) in T22S, R7W, Sec.30. Monument lies at east edge of Henderer Road at center of a cattle undercrossing approx. 170 ft. north of intersection.
