OFFICE OF THE  
DOUGLAS COUNTY SURVEYOR

Station: U75 RESET T 22 S, R 10 W, Sec 13  
 Set By (Agency): DCSO  
 Date Set: 1983  
 Recovered By GQ,JP  
 Date Recovered 5/83  
 Recovered By \_\_\_\_\_  
 Date Recovered \_\_\_\_\_  
 Recovered By \_\_\_\_\_  
 Date Recovered \_\_\_\_\_

U-077 22S 10W 13  
 U-75 RESET

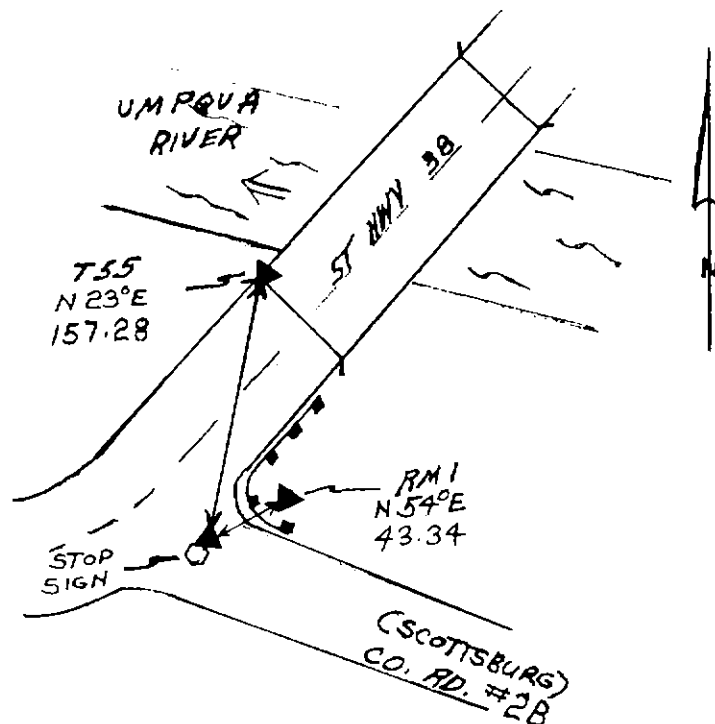
SKETCH

Found a standard DCSO disk set in 6 in. diam. concrete filled belltile with top of tile and cap destroyed. Monument is solid and we reset a DCSO disk stamped "U75 RESET 1983".

A standard USC&GS disk stamped "T55 1930" bears N 25°26'20" E, 157.28 ft. (grid)

A standard DCSO disk stamped "U75 RESET RM1 1983" bears N 56°25'16" E, 43.34 ft. (grid)
