OFFICE OF THE
DOUGLAS COUNTY SURVEYOR

Station: VIRGINIA

T 27 S, R 6 E , Sec 32

V-028
VIRGINIA

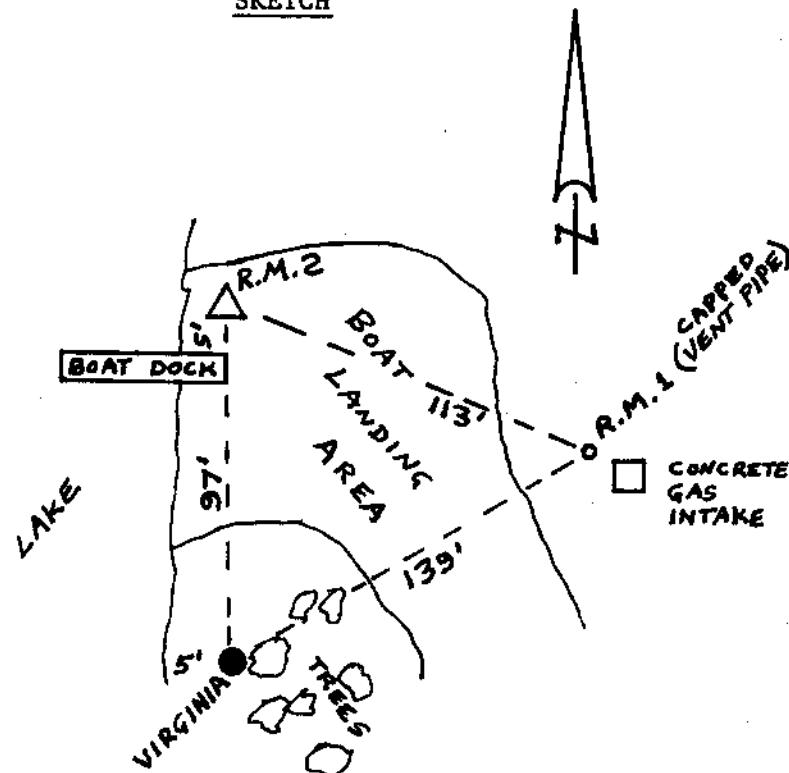
SKETCH

Stem of brass cap in 2 ft. diameter boulder under a bush, 40 ft. south of boat ramp, 5 ft. east of water.

Reference Marks:	VIRGINIA R.M. 1	Center of vent pipe west of concrete gas intake	(El. 5193.905)
		553,983.04 1,563,454.85	
	VIRGINIA R.M. 2	Brass cap in 2 ft. diameter boulder	(El. 5184.790)
		553,942.38 1,563,350.58
